RALPH C. TYLER, P.E., P.S., INC.  
CIVIL ENGINEERS & LAND SURVEYORS  
2143 FAIRHILL RD., CLEVELAND, OHIO 44106

GENERAL PLAN &  
TRANSVERSE SECTION  
S.R. - 306  
LAK-90-0767

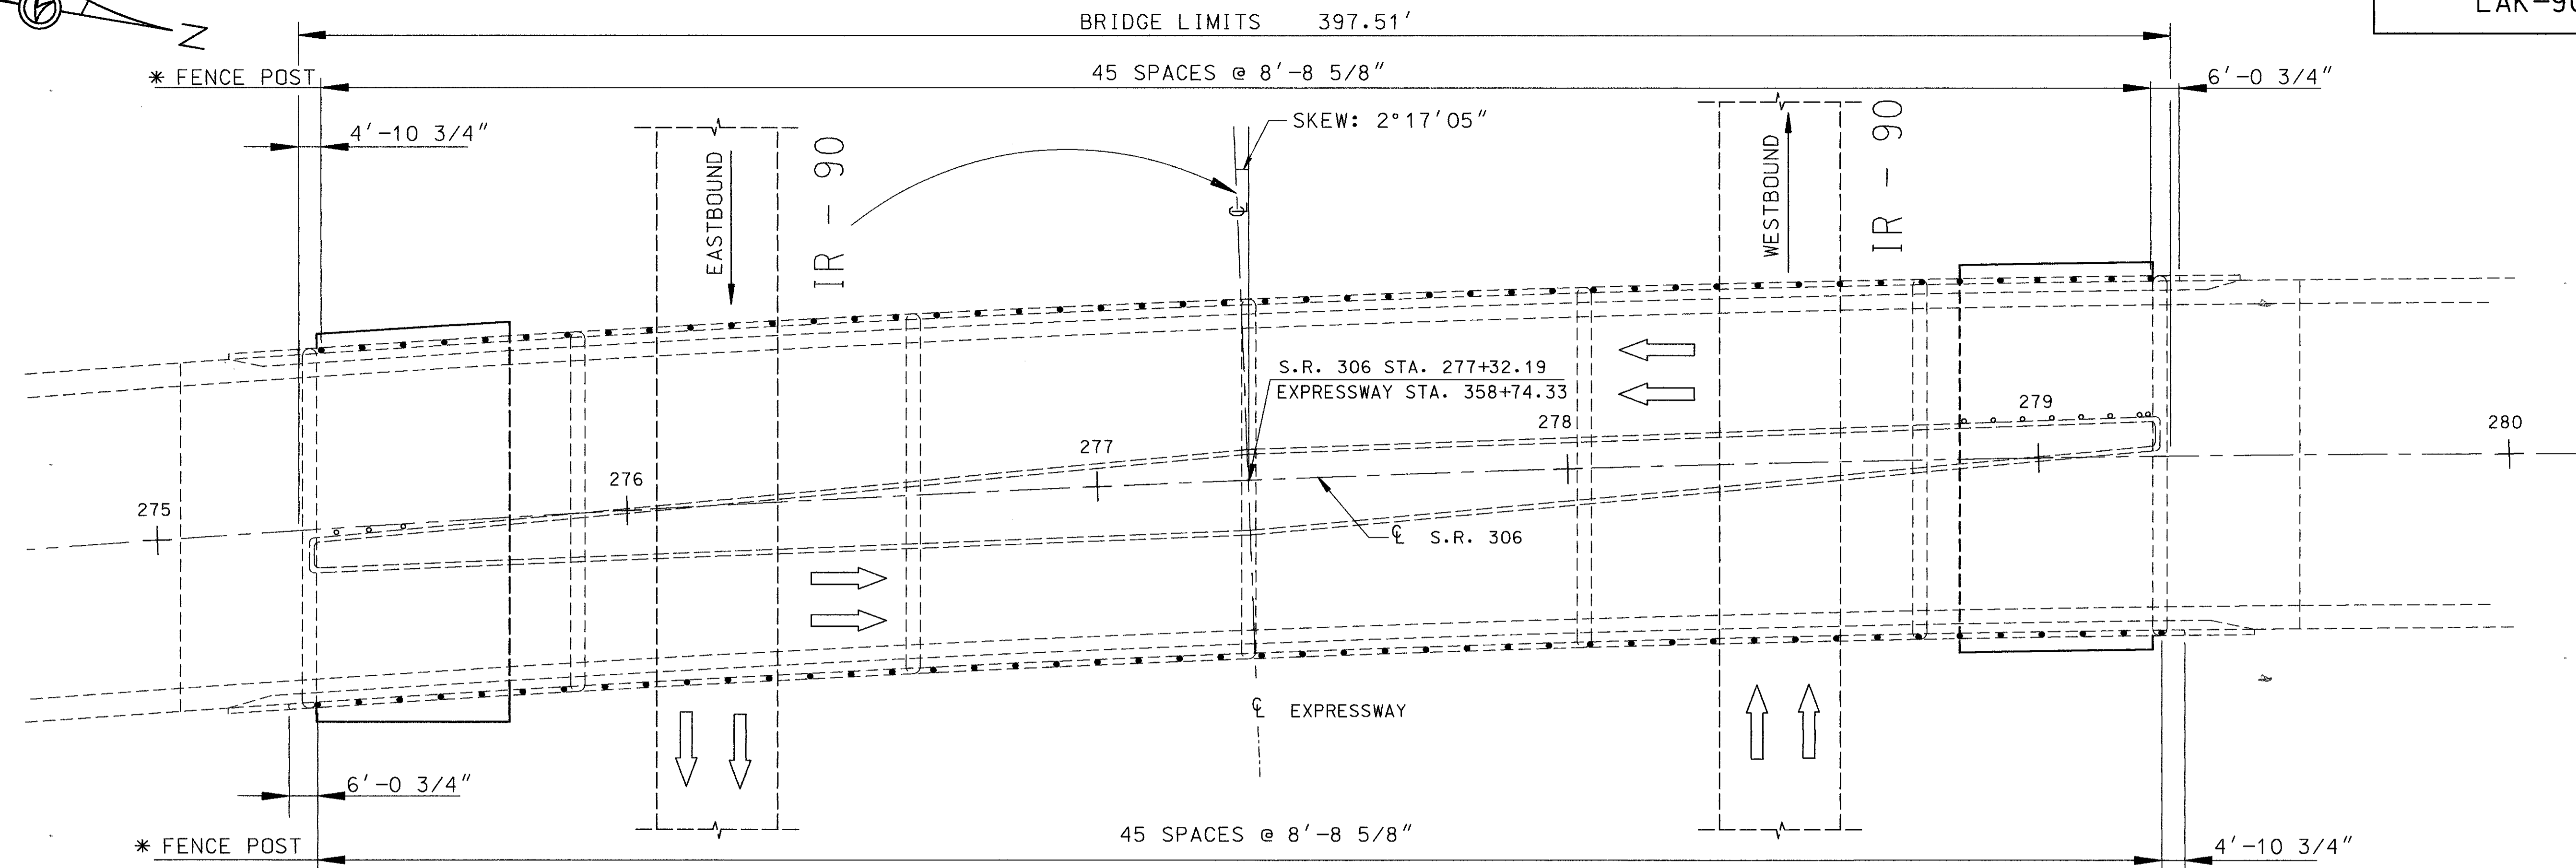
PLAN

NOTE:  
WORK ON STEEL BEAM REQUIRES PROVIDING A HOLE TO STOP THE FATIGUE STRESS CRACK FROM EXPANDING OVER MID-PIER, BEAM 7 FROM WEST-END.

- PROPOSED WORK:
1. SLOPE REPAIR AND PROTECTION.
  2. PATCHING AND SEALING OF CONCRETE SURFACES.
  3. GUARDRAIL INSTALLATION.
  4. PEDESTRIAN FENCE INSTALLATION
  5. RESET TILTED BEARINGS.
  6. WEARING SURFACE HMWM TREATMENT.
  7. EPOXY INJECTION REPAIR OF DECK.
  8. END CROSS FRAMES REPLACEMENT.
  9. SCUPPER PIPE REPAIR.
