LAK 2 - 3.32 Parcel 9 PID 13486
36628 Vine Street, Eastlake, Ohio

2 sty. Brick/frame commercial house
w/ basement & asphalt shingle roof

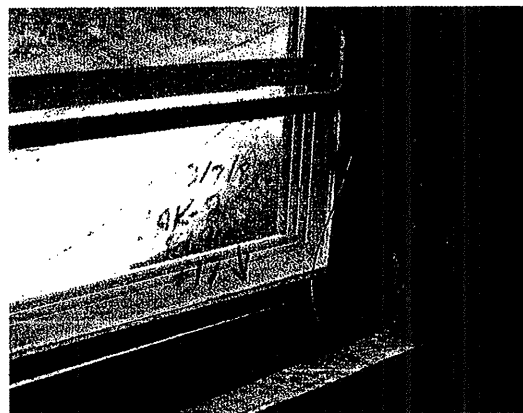
Sample #17 Window Glaze/caulk, 2nd Flr.
Hallway 3% Chry (PLM) PC 2.25% ACM

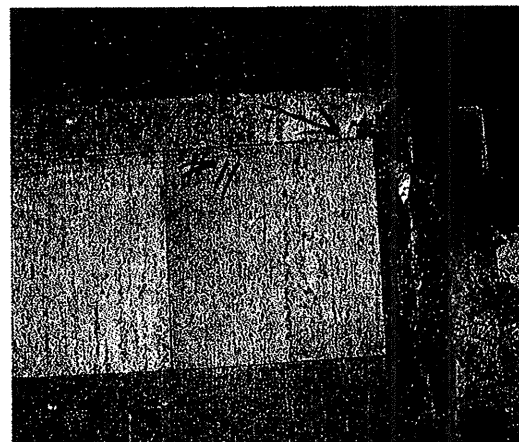
Sample #11 Vinyl Flooring Tile&Mastic
3% Chry (PLM) Assume all ACM
