PROPOSED REPAIR WORK

STATE OF OHIO
DEPARTMENT OF HIGHWAYS
DIVISION OF DESIGN AND CONSTRUCTION
BUREAU OF BRIDGES

SUPERSTRUCTURE REPAIRS
BRIDGE N° LAK-90-0171
UNDER ROCKEFELLER RD.

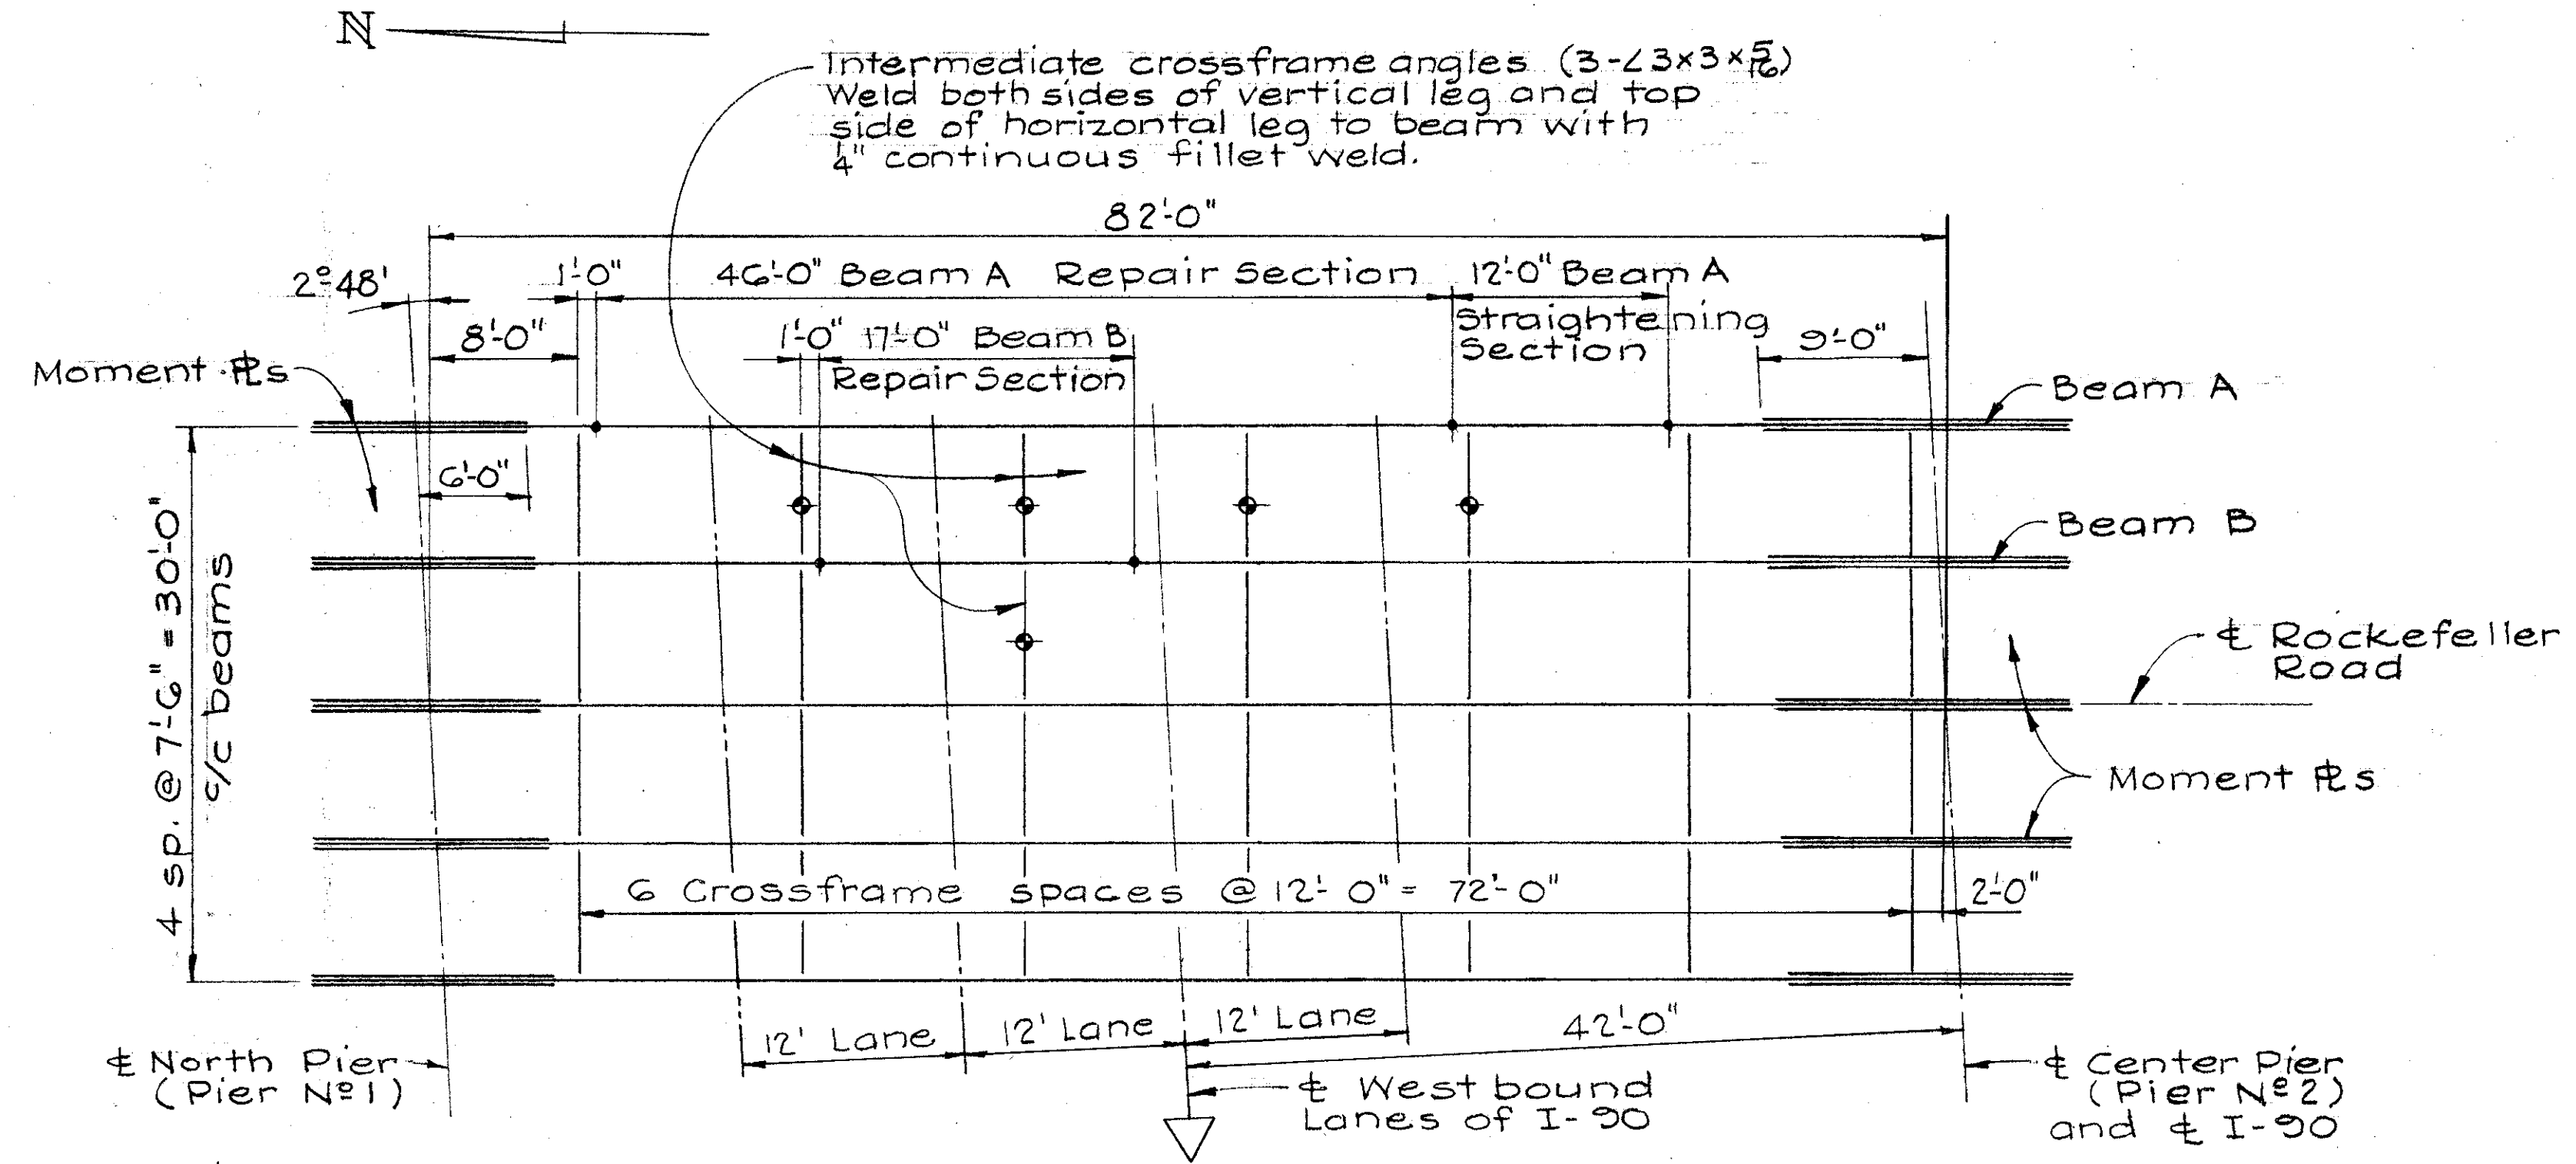
PART FRAMING PLAN

◆ Denotes damaged crossframes to be replaced with new steel.

4. Flame cut and remove the damaged portion of the existing beams to the limits shown on the plans and remove the damaged crossframes as noted for replacement.

6. Insert the beam repair sections, jack into position and weld. Install new crossframes.

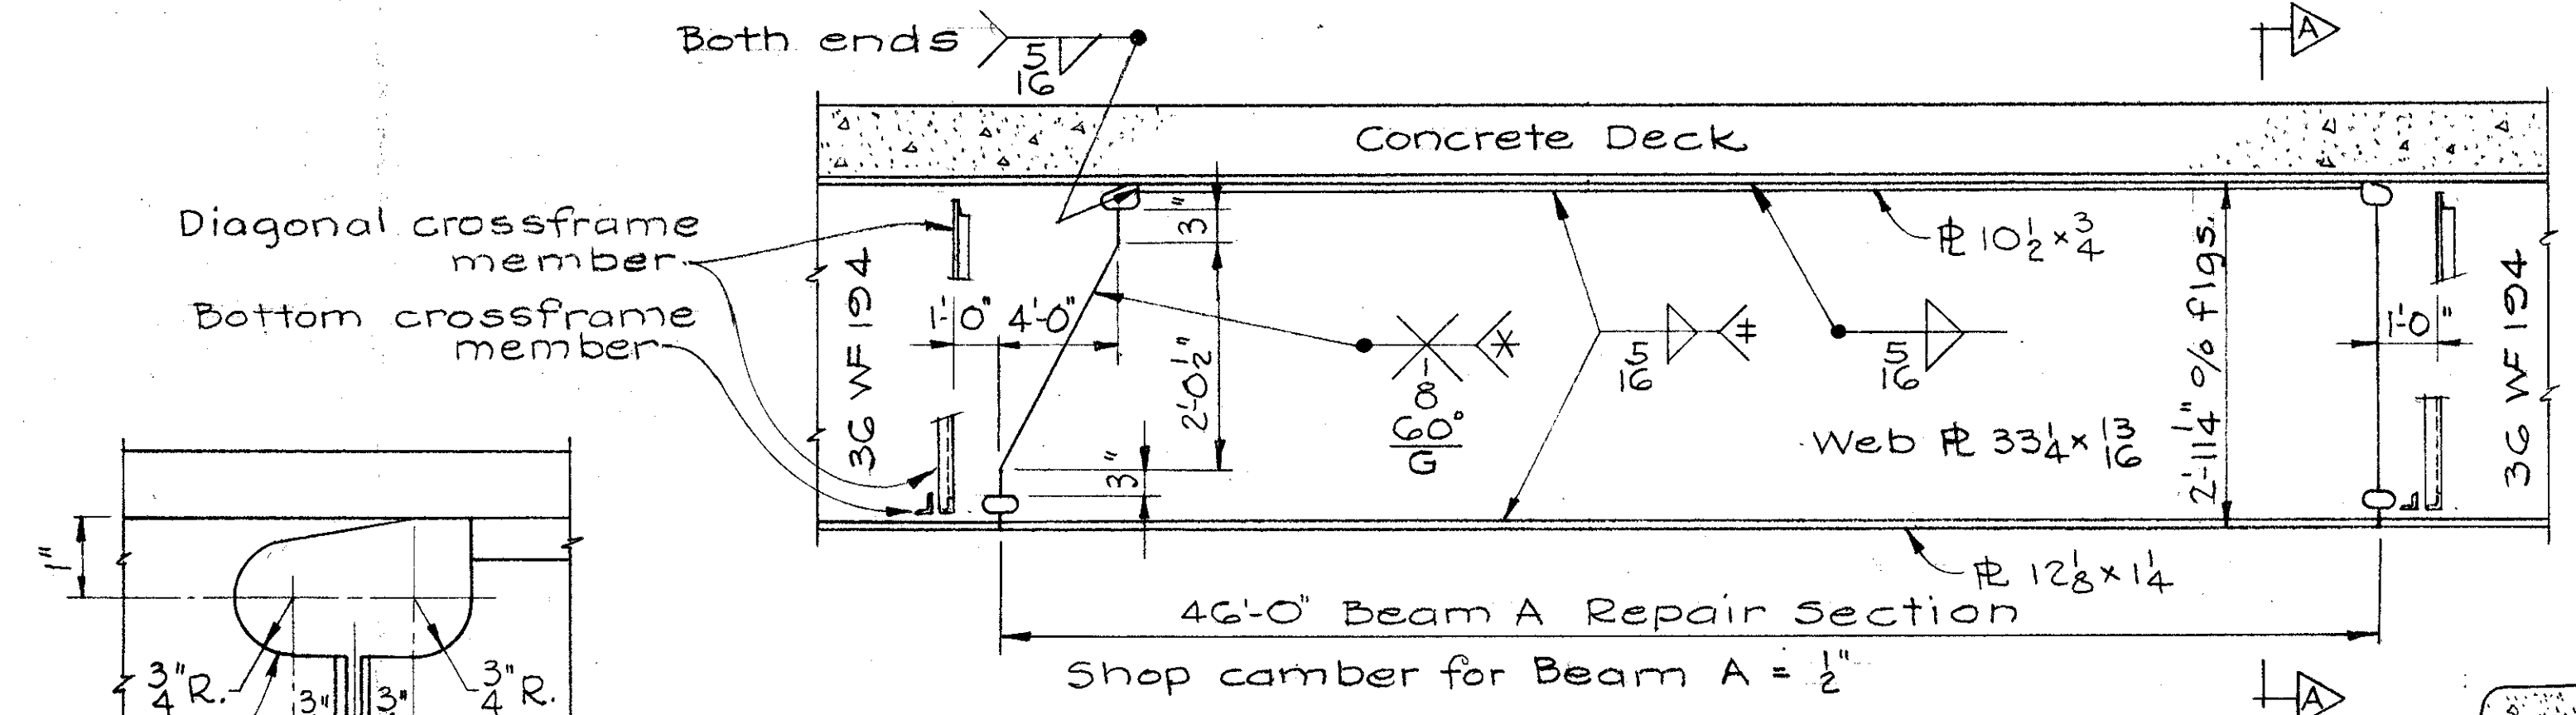
REPAIR SECTIONS

- * Will require Radiographic Examination as per 811.
- † Will require Magnetic Particle Examination as per 811.

The damaged portion of the existing 36WF194 of Beam A Repair section shall be removed to the limits shown. The remaining steel shall be ground flush with the underside of the top flange. No gouging of the top flange will be permitted. Gouging of the webs and bottom flanges during removal no deeper than 3/8" will be acceptable for either repair section; however, no protrusions will be permitted.

5. Grind the web and fillet of Beam A flush with the bottom of the top flange, which is to remain in place. Prepare the ends of the existing beams for welding as noted on the plans.

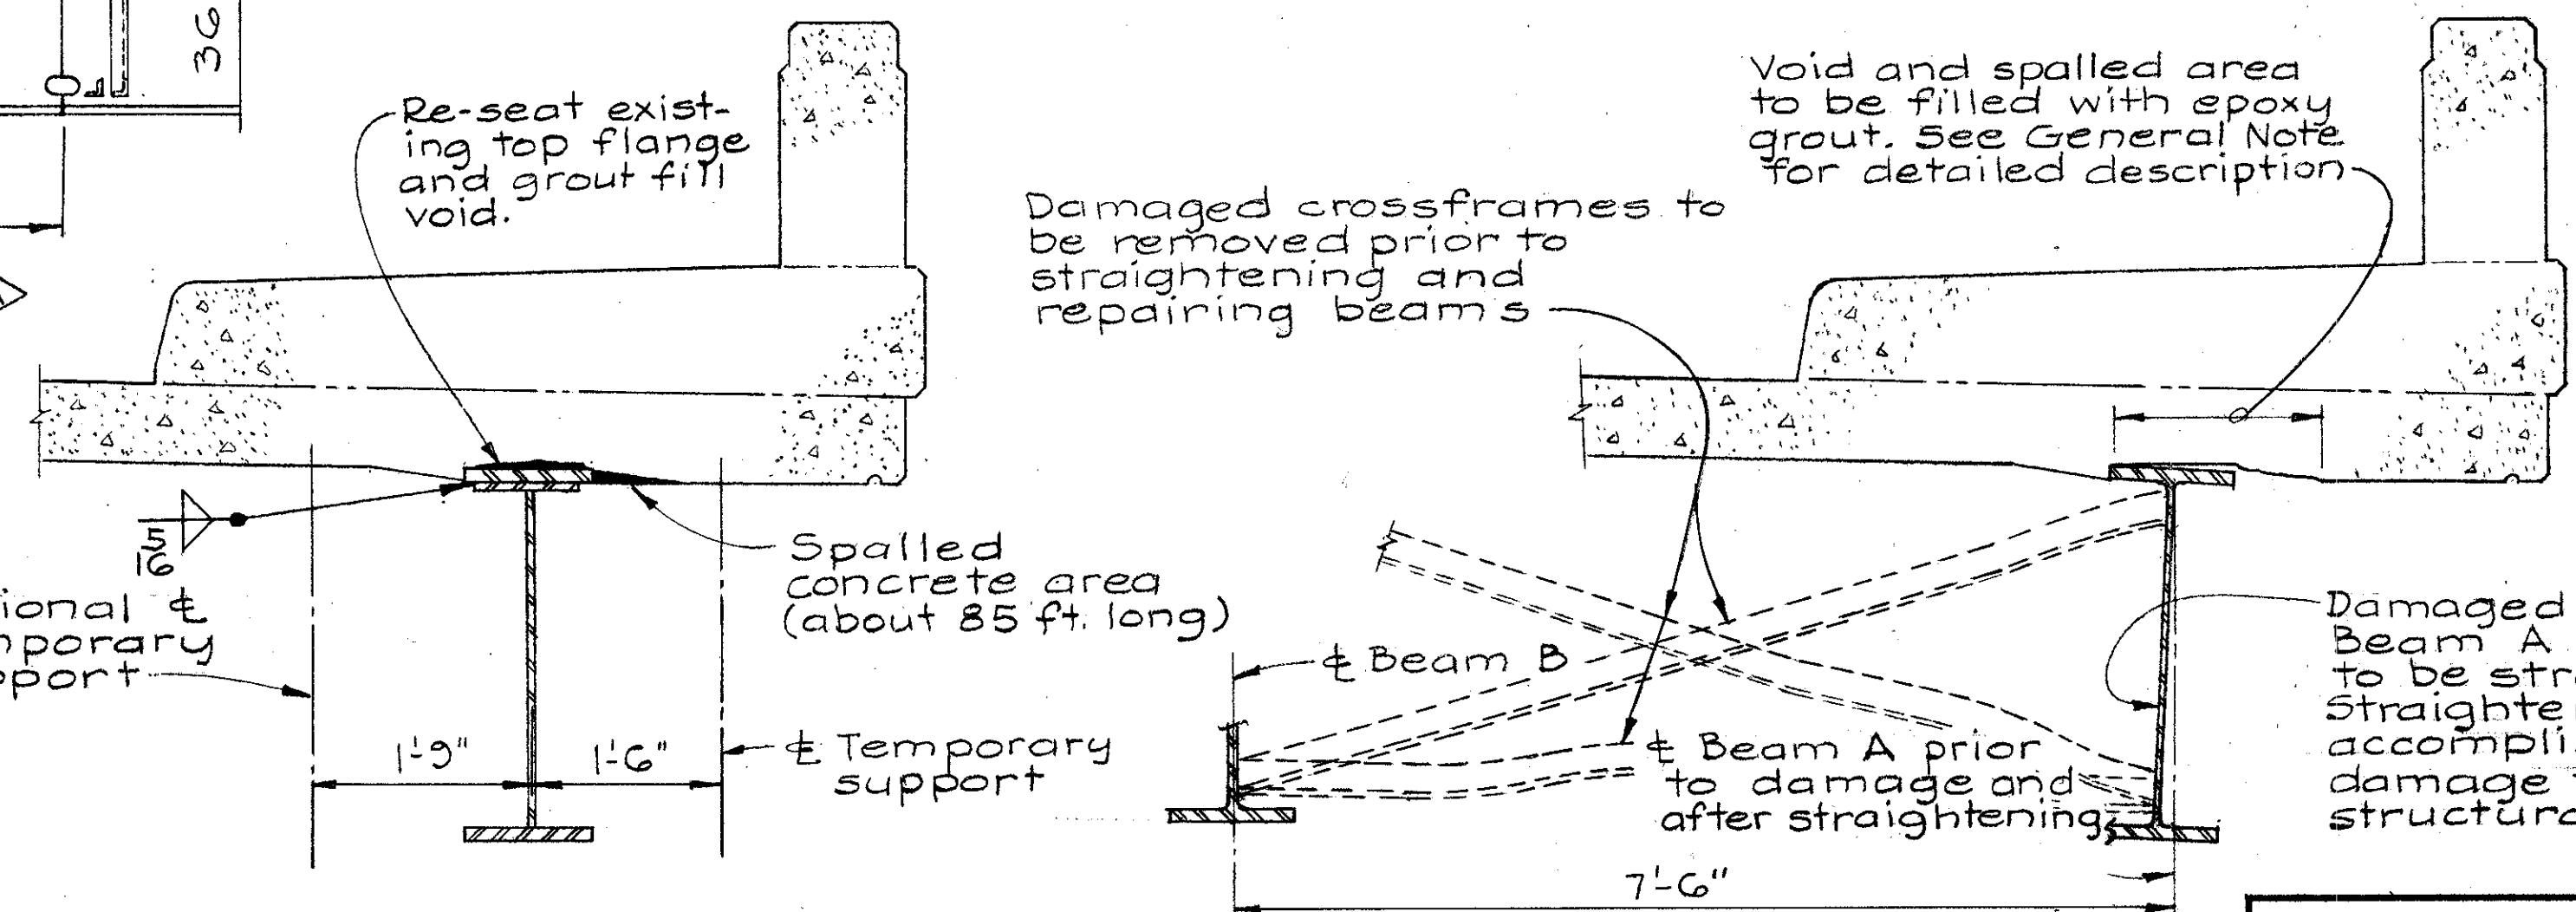
SECTION A-A

SECTION THRU DAMAGED AREA

1. Provide for maintenance of traffic on Interstate 90 and close Rockefeller Road as required by the plans.
2. Place shoring under the easterly curb at the support location shown on Section A-A on sheet 2 of the plans and at the longitudinal quarter points and mid-point of the damaged span. Additional shoring shall be placed under the bottom flange of Beam B immediately beyond the limits of the repair of that beam. Jacks shall be used to maintain continuous adjustment throughout the required beam repairs. All jacks shall be raised in increments so that the deck of the structure is supported proportionally at all jacking points.
3. The deck jacking shall raise the superstructure as follows:

Jacks shall have a minimum capacity of twenty (20) tons per support adjacent to Beam A and fifteen (15) tons per support under Beam B. Elevations may be taken on the surfaces of the deck and sidewalk for verifying the jacking dimensions. Deck and sidewalk elevations shall be recorded: (a) prior to applying jacking loads, (b) after jacking is completed, (c) after damaged portions of the beams are removed and prior to readjustment of jacks for replacement of new beam members, (d) after adjustment for replacement of new beam members, and (e) after completion of the beam repairs and removal of the jacks and supports. The jacking records shall be forwarded to the Director for review by the Bureau of Bridges.
