END FRAME REPLACEMENT

PACK RUST REPAIR AND CAULKING DETAILS

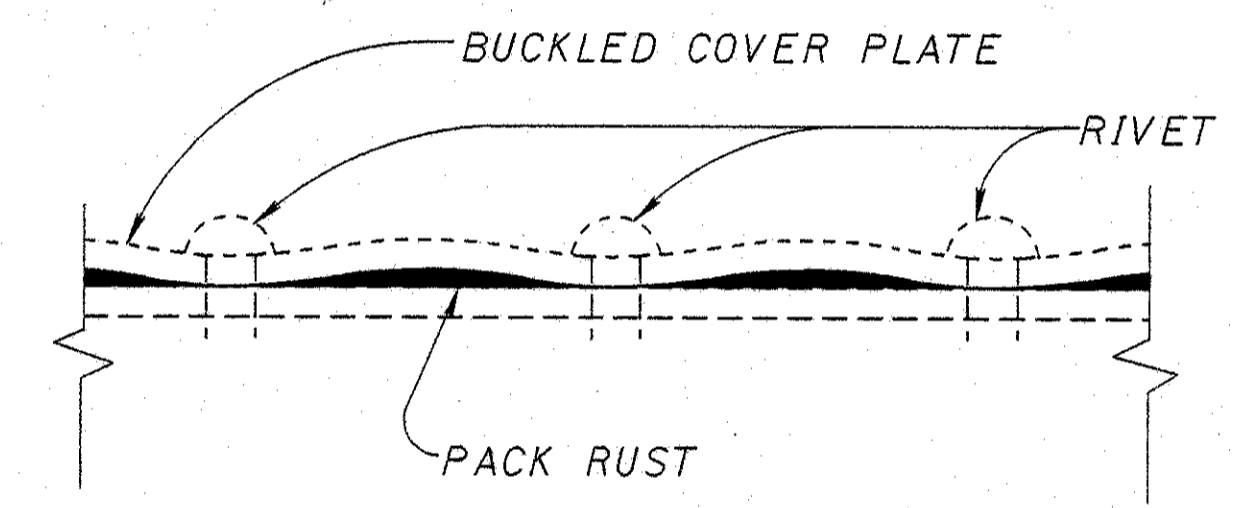
EXISTING TRUSS CHORD COVER PLATE CONDITION
