SR 82 (Royalton Road)
 INTERCHANGE

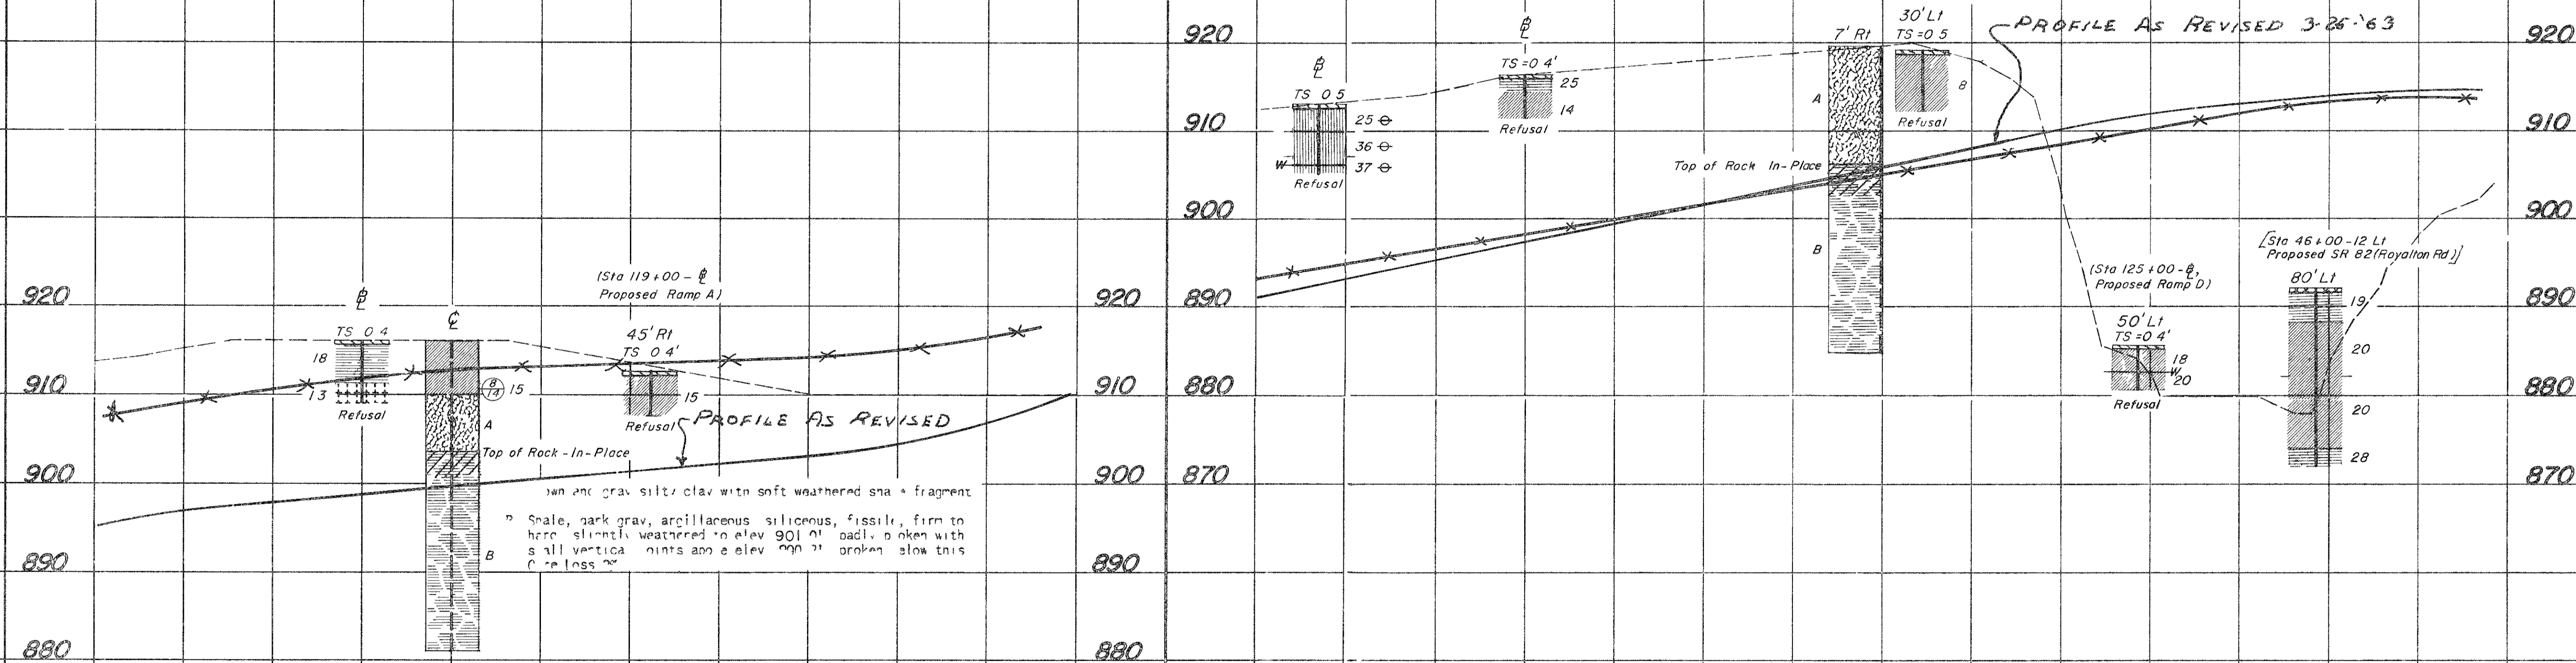
STATION 12+00 71'2"

- A Brown silty clay with soft weathered shale fragments and sandstone cobble sand fragments
- B Shale, dark gray, argillaceous, siliceous, slightly fissile, firm to hard, slightly weathered to elev 902.71, badly broken above elev 901.71, below, vertically jointed at 1' intervals below elev 901.71. No ore loss.
