Burgess & Niple, Limited **bn** 15 / 24  
Engineers and Architects

ABUTMENT REPAIRS & DETAILS  
BRIDGE NO. LAK-91-0423  
S.R. 91 OVER N & W R.R. & CONRAIL R.R.

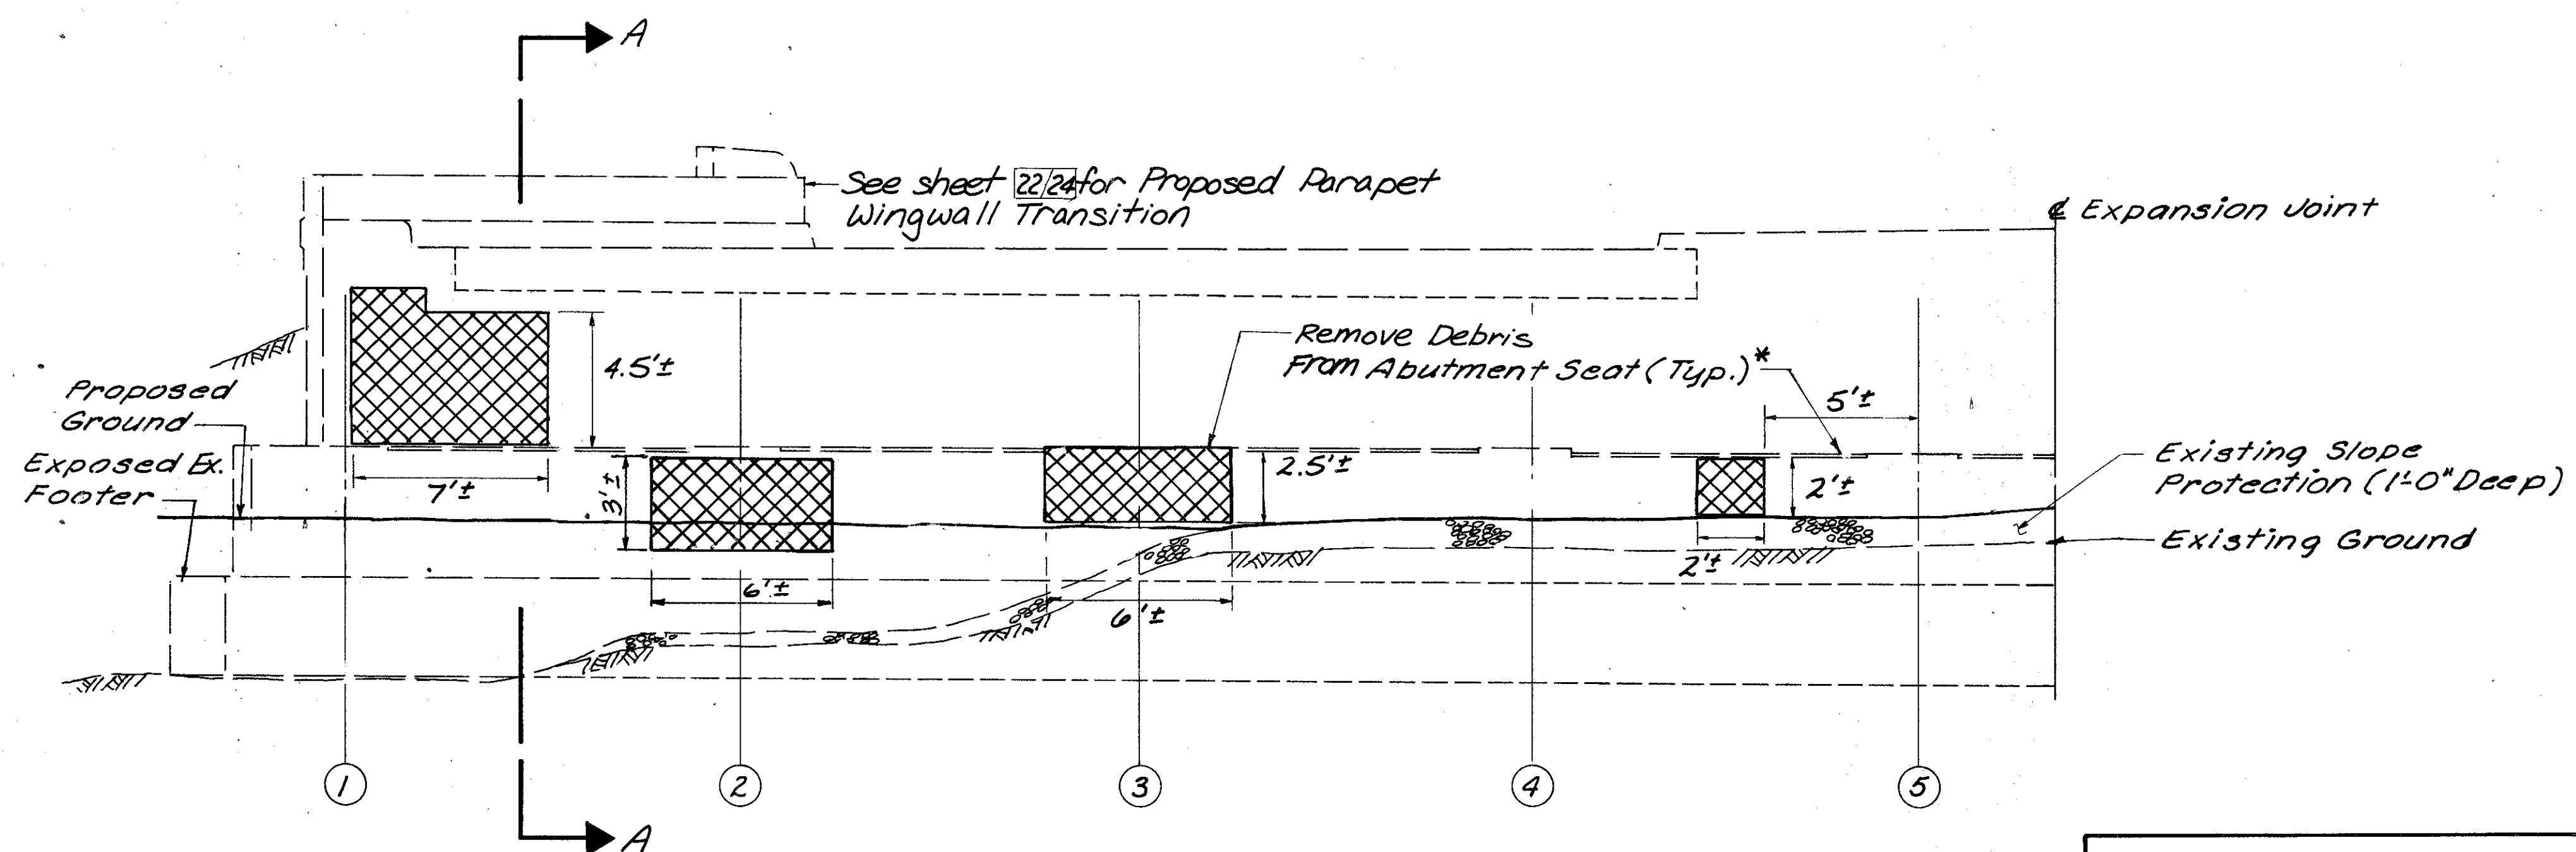
SOUTHBOUND

No Deterioration Apparent on Rear Abutment.

Estimated Quantity Has Been Increased By 50 S.F. Over Measured Quantities To Allow For Additional Deterioration.
