H.N.T.B. 88 # 36A
OHIO STATE HIGHWAY TESTING LABORATORY
1620 WEST BROAD ST. COLUMBUS 23, OHIO
STRUCTURE FOUNDATION INVESTIGATION
BRIDGE NO. CUY-80-1594
SANITARY SEWER
SEC. CUY-80-1581
DRIVE ROD PENETRATION RESISTANCE DATA
PLOTTED BY J.M.M. CHECKED BY L.N.L. REVIEWED BY R.D.R. DATE 10/9/69

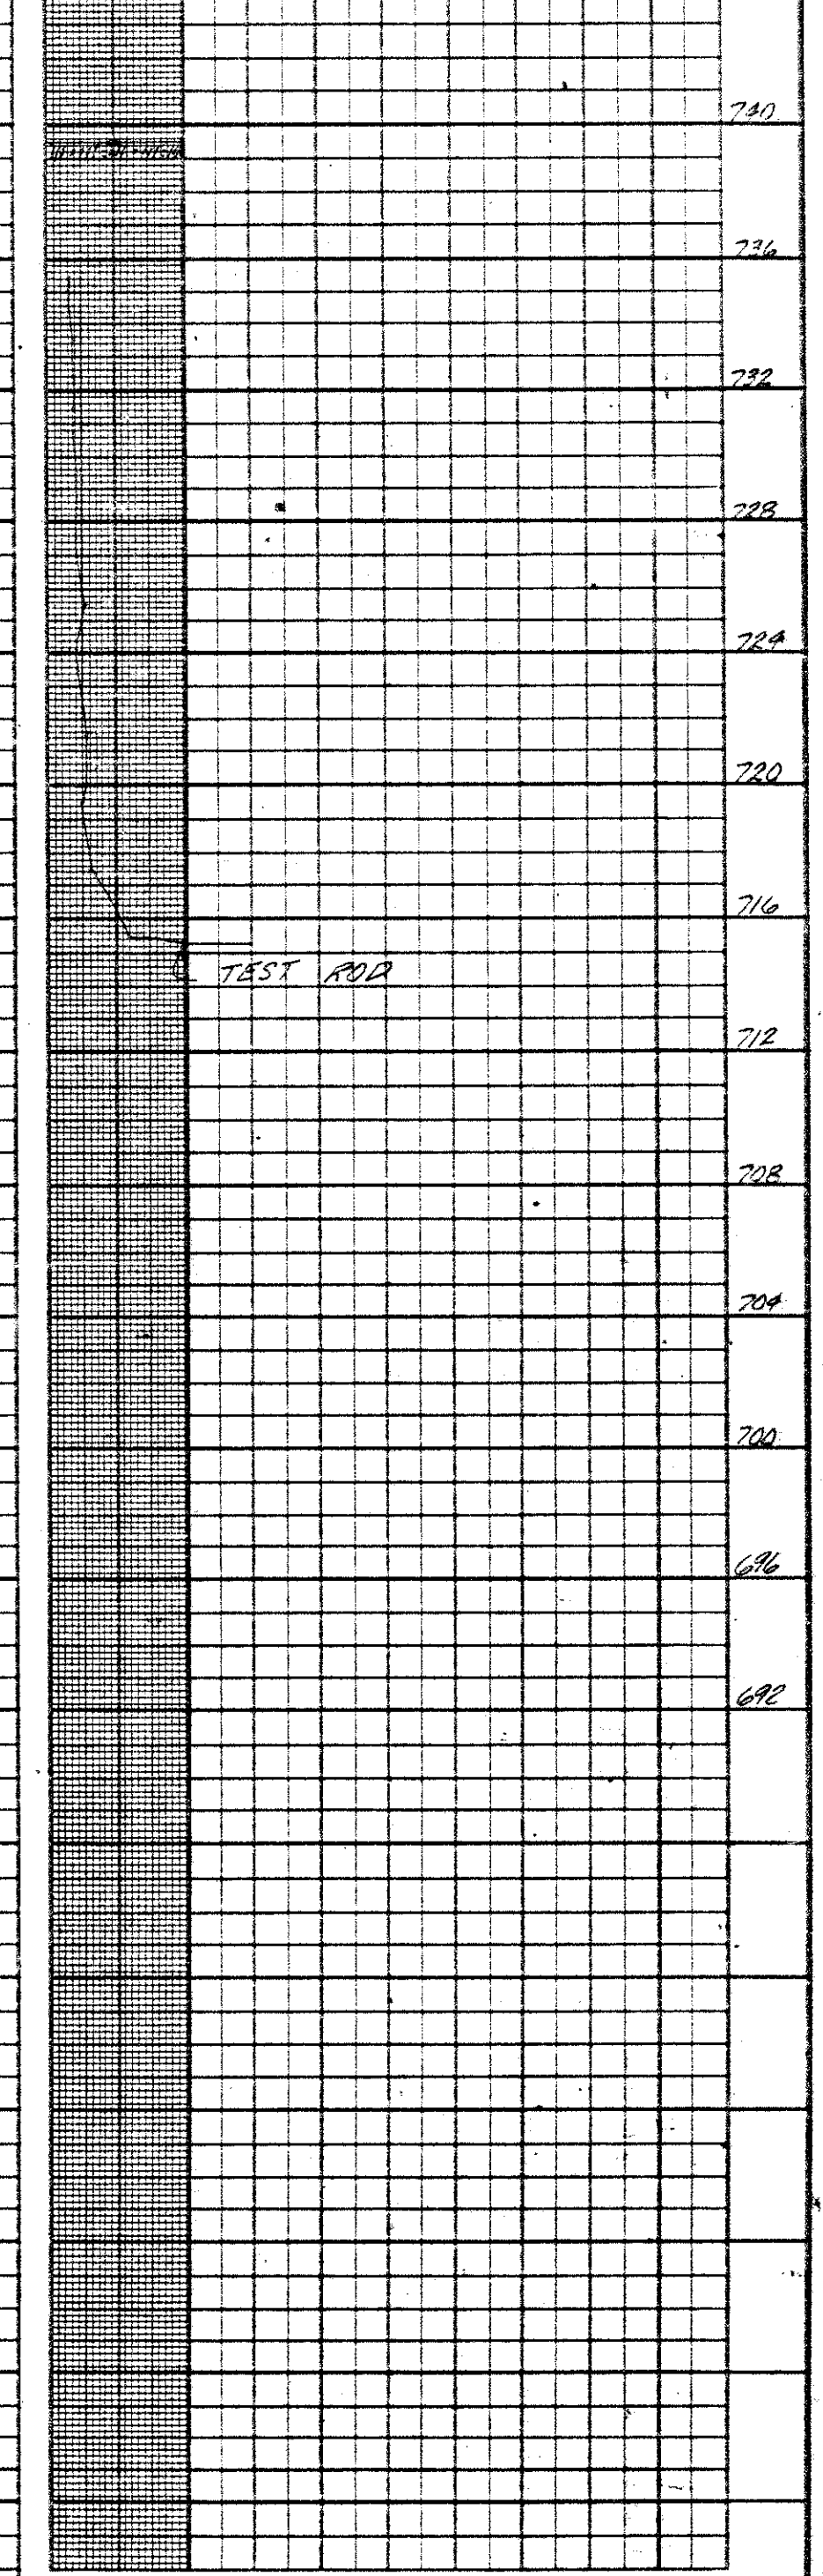
Test Location No. 3
Station & Offset 342+70
Surface Elev. 739.5 Water Elev. 721.16
Rod Condition 3000

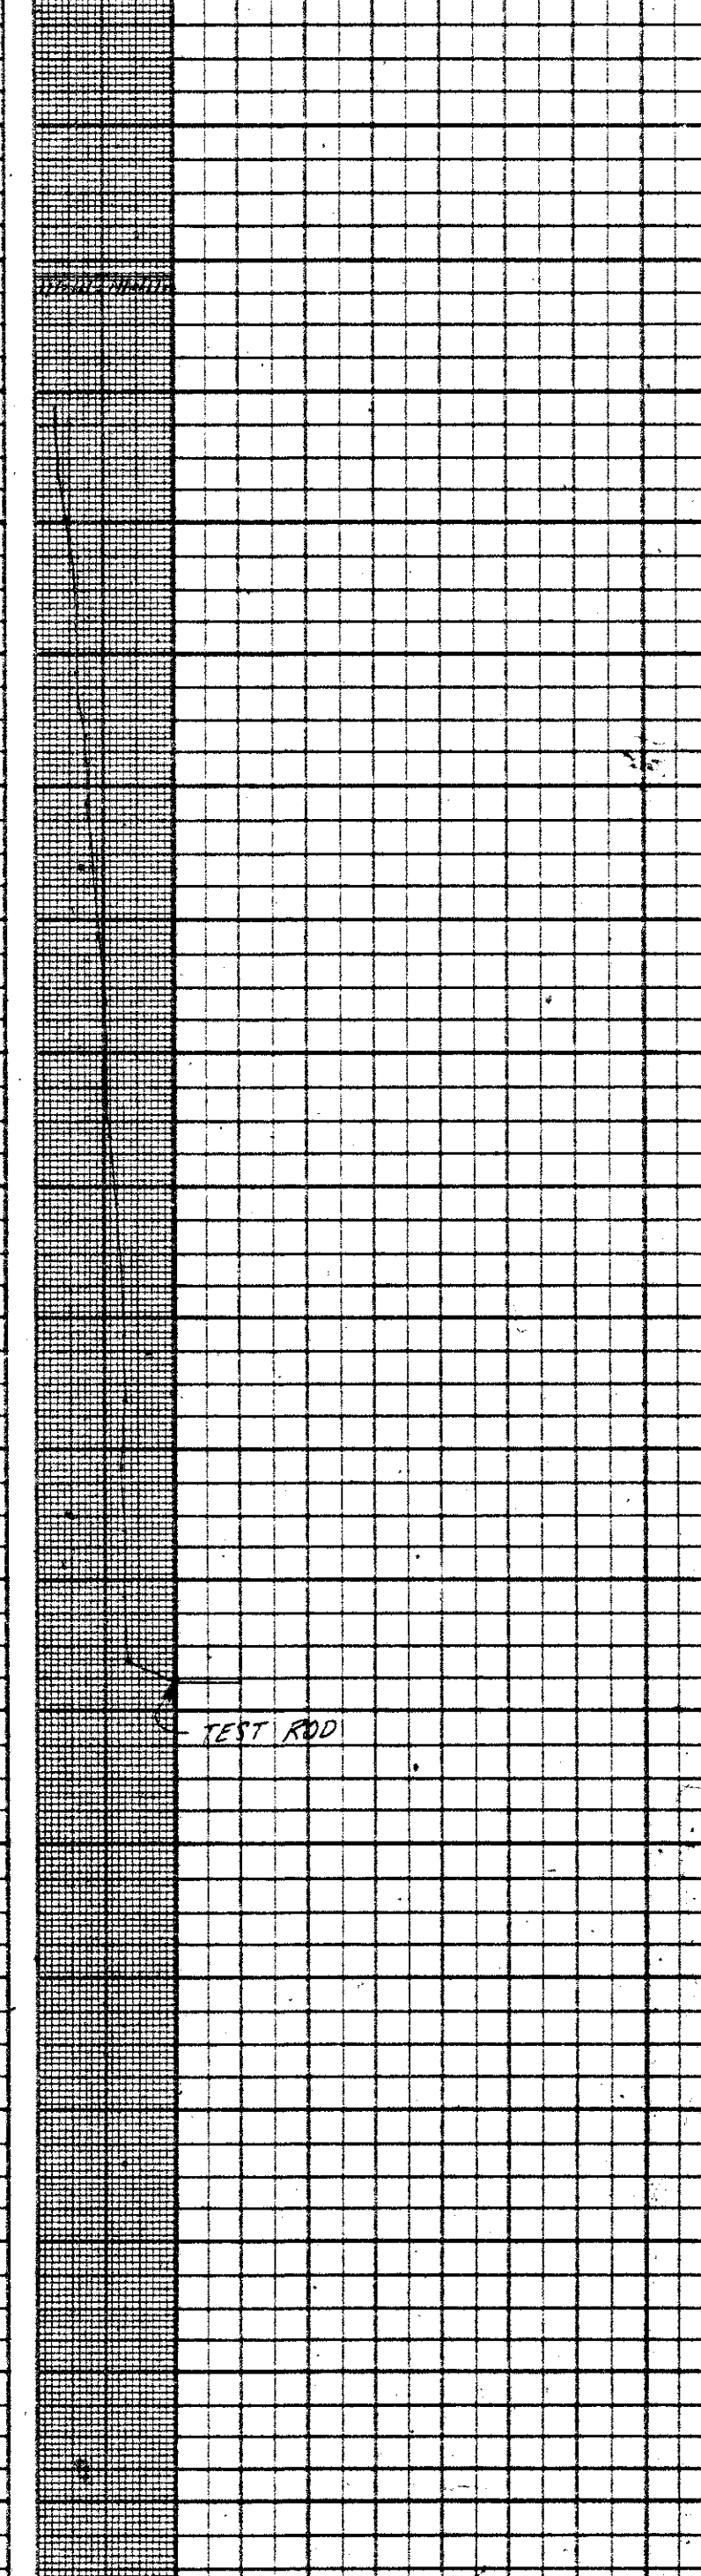
Test Location No. 1
Station & Offset 265+27
Surface Elev. 735.3 Water Elev. 170.15
Rod Condition 3000

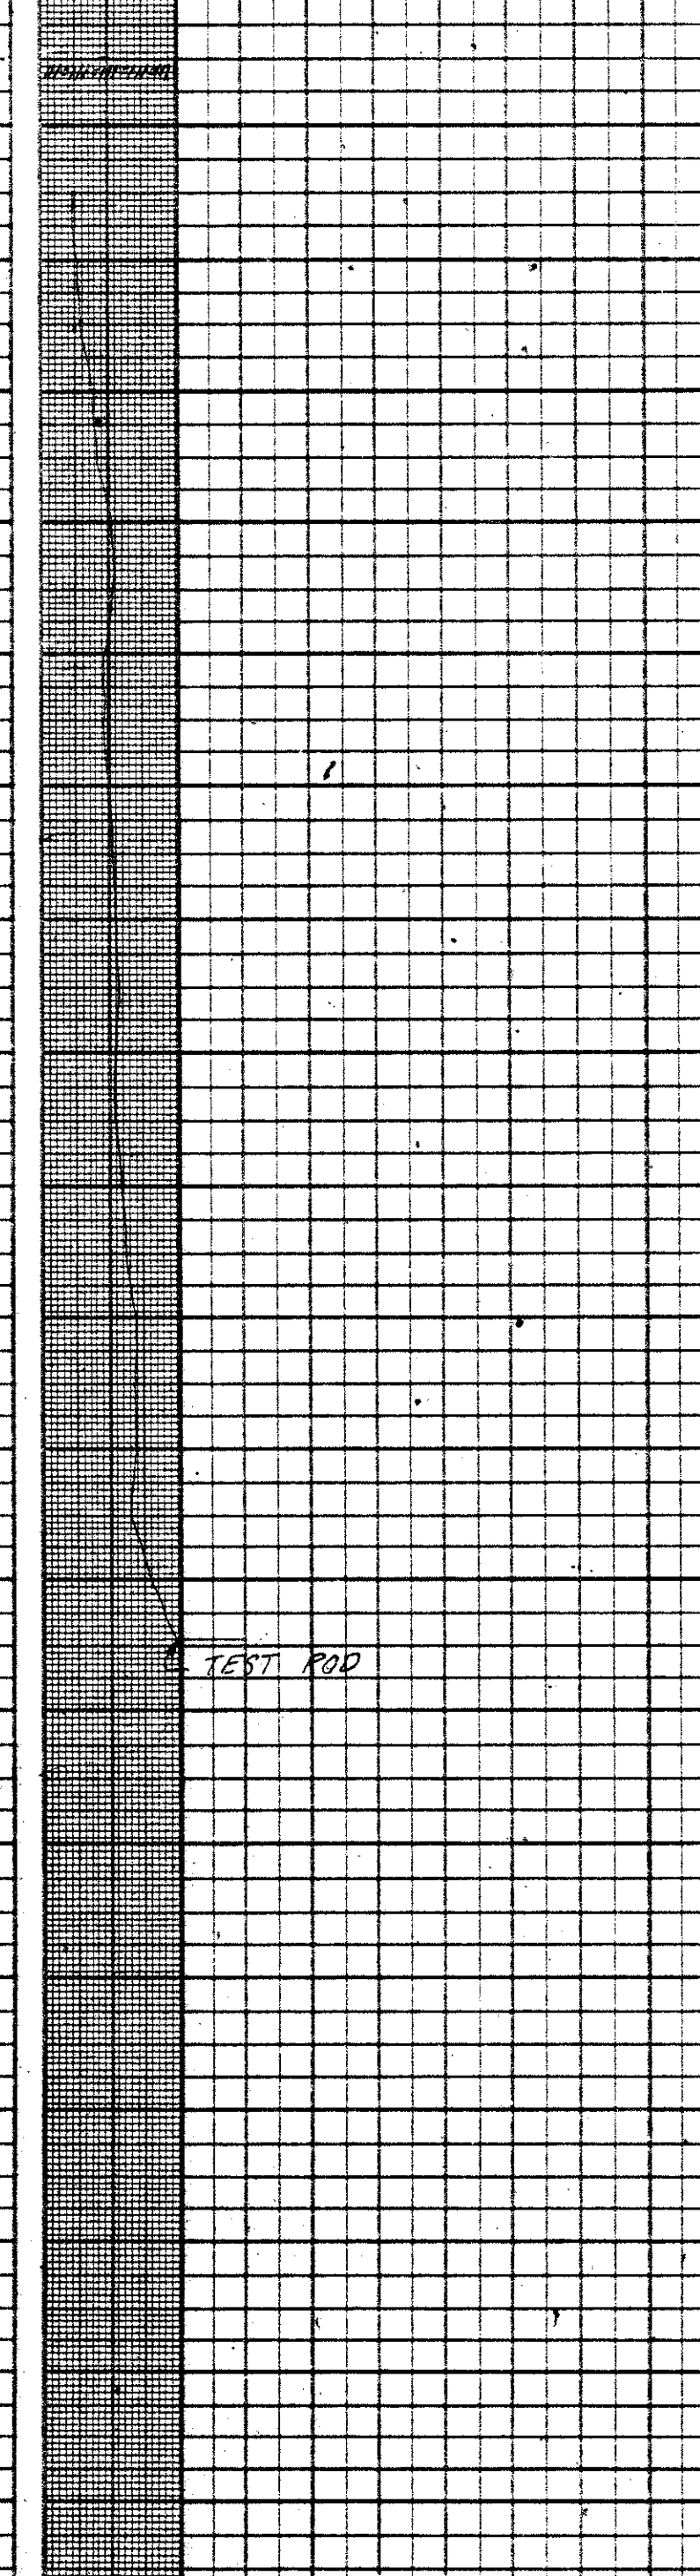
Test Location No. 2
Station & Offset 265+10
Surface Elev. 744.2 Water Elev. 140.15
Rod Condition 3000
