ARCOLA CREEK RESTORATION PLAN

LAK-20-28.014

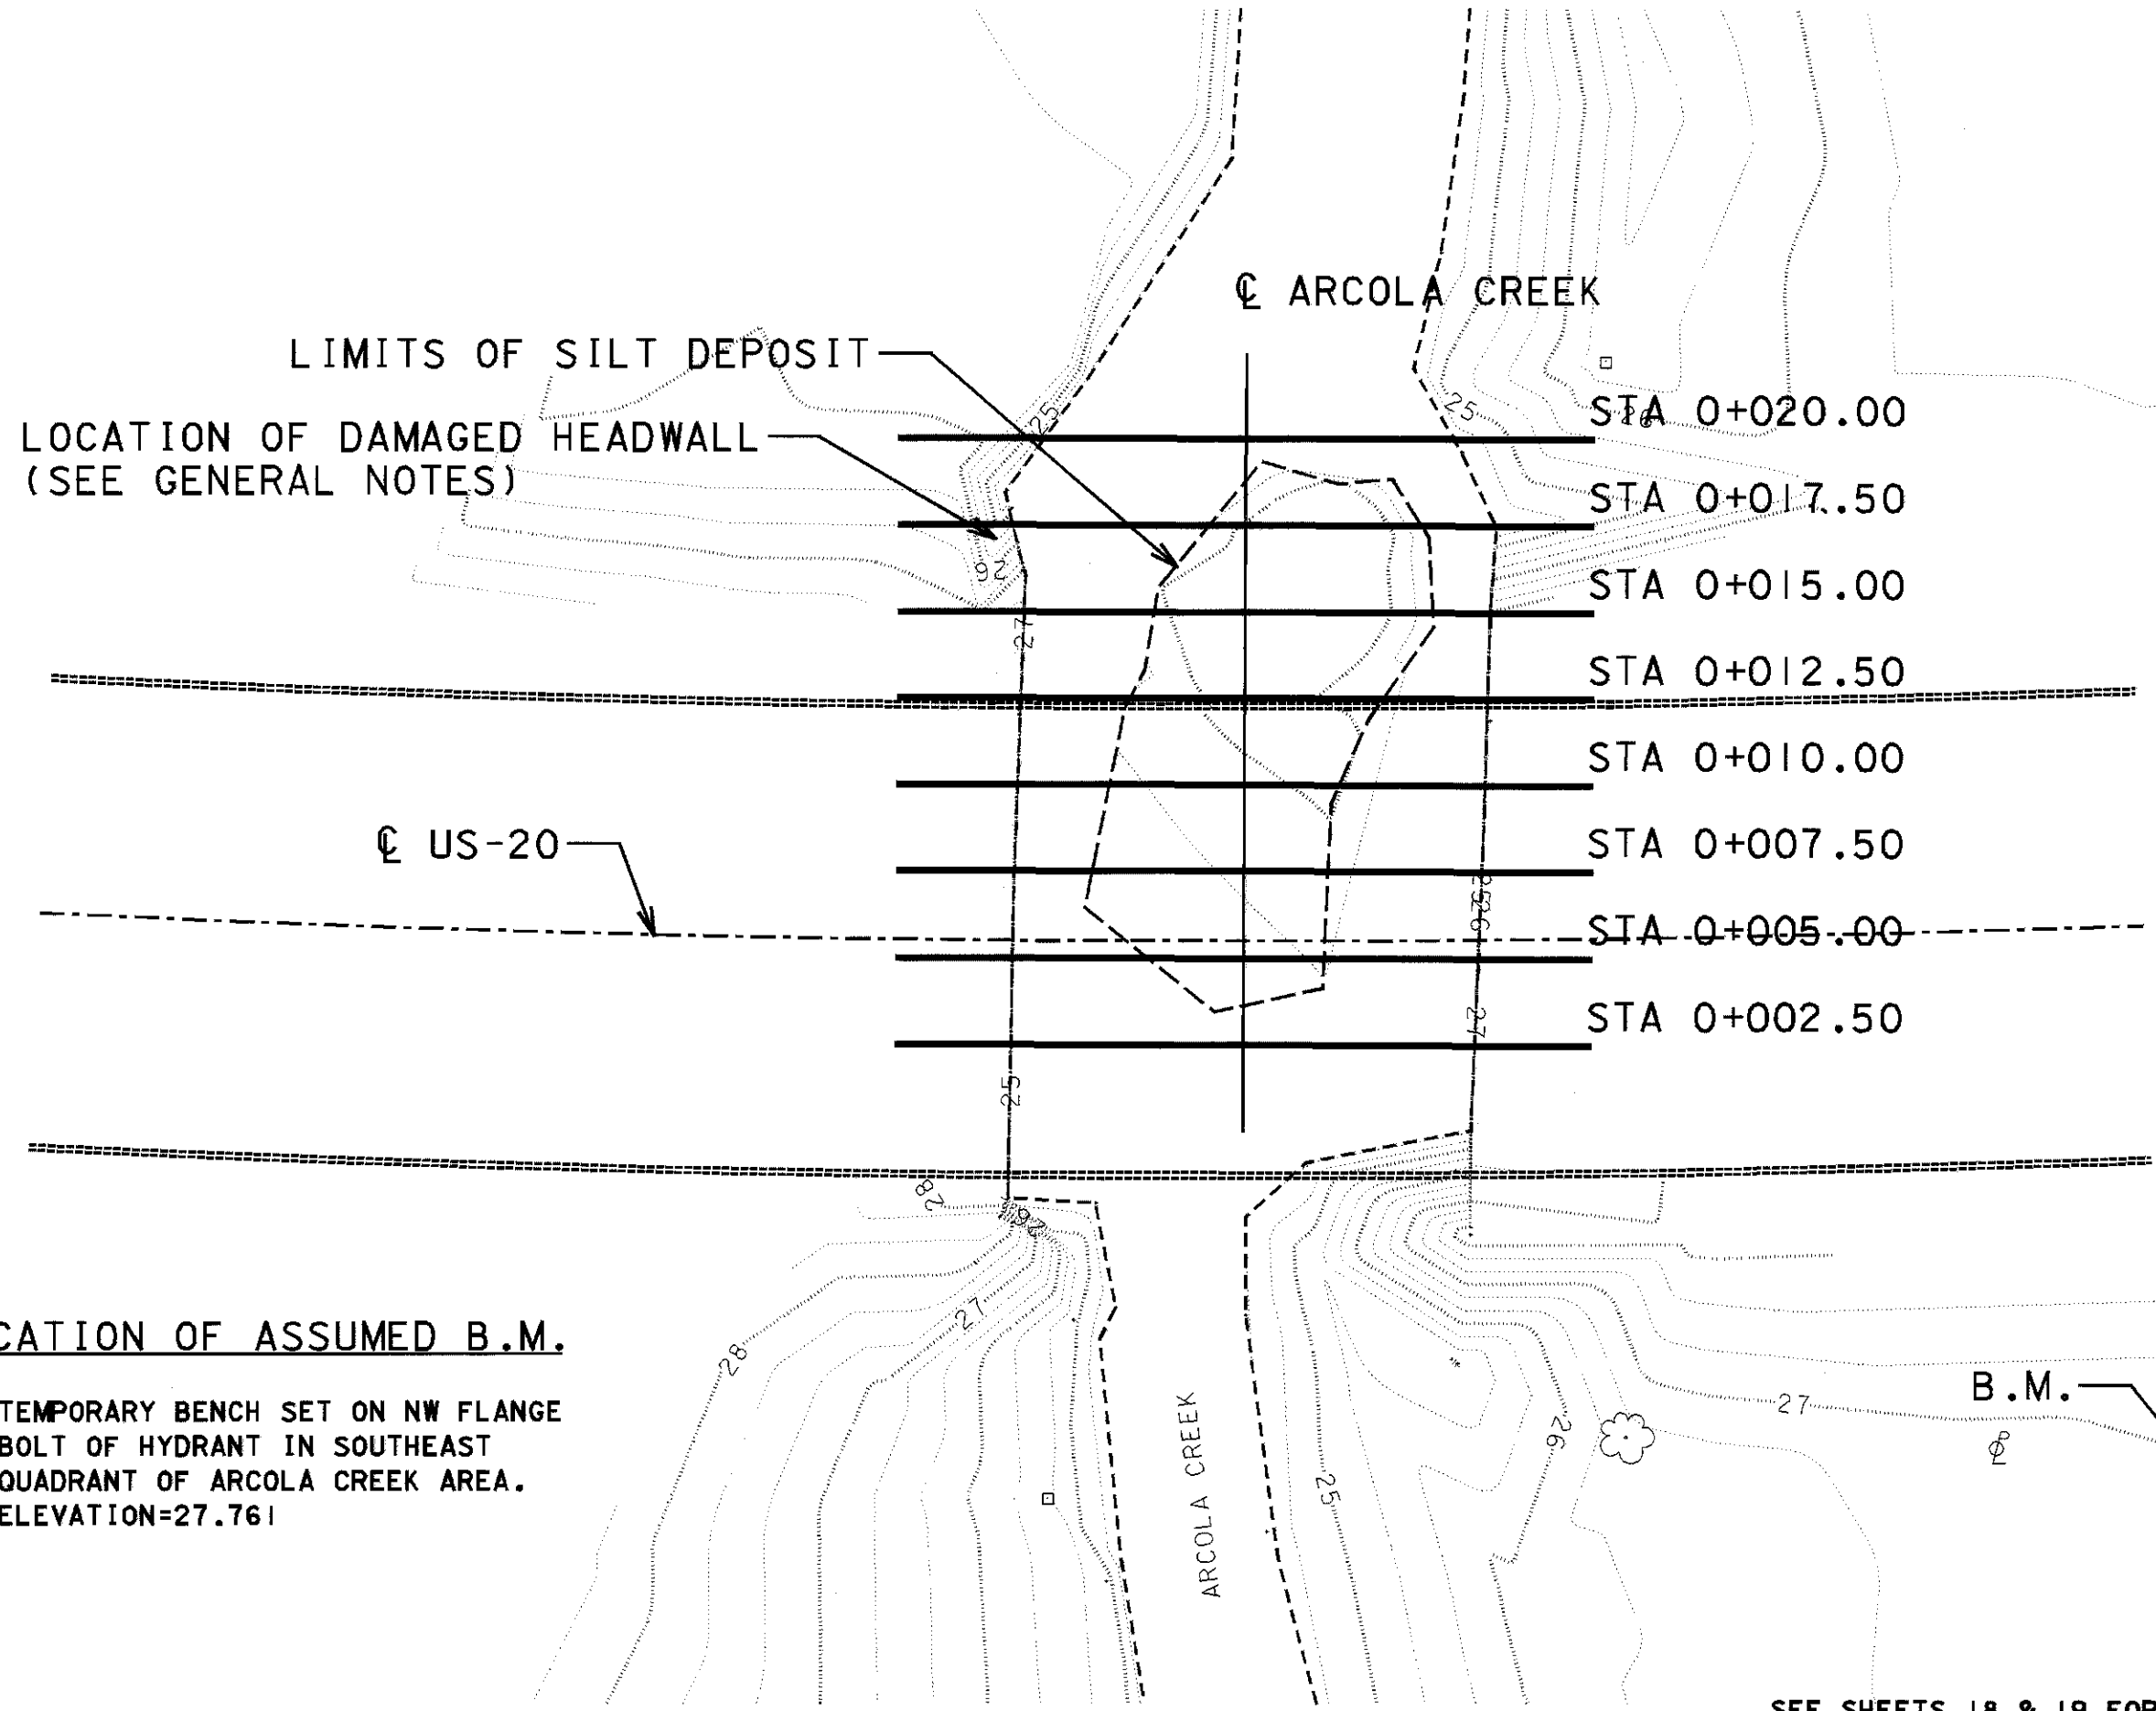
LIMITS OF SILT DEPOSIT

LOCATION OF DAMAGED HEADWALL
(SEE GENERAL NOTES)

LOCATION OF ASSUMED B.M.

TEMPORARY BENCH SET ON NW FLANGE
BOLT OF HYDRANT IN SOUTHEAST
QUADRANT OF ARCOLA CREEK AREA.
ELEVATION=27.761

SEE SHEETS 18 & 19 FOR CROSS SECTIONS
