MISCELLANEOUS DETAILS
SR-86

LAKE COUNTY
LAK-86-1.71

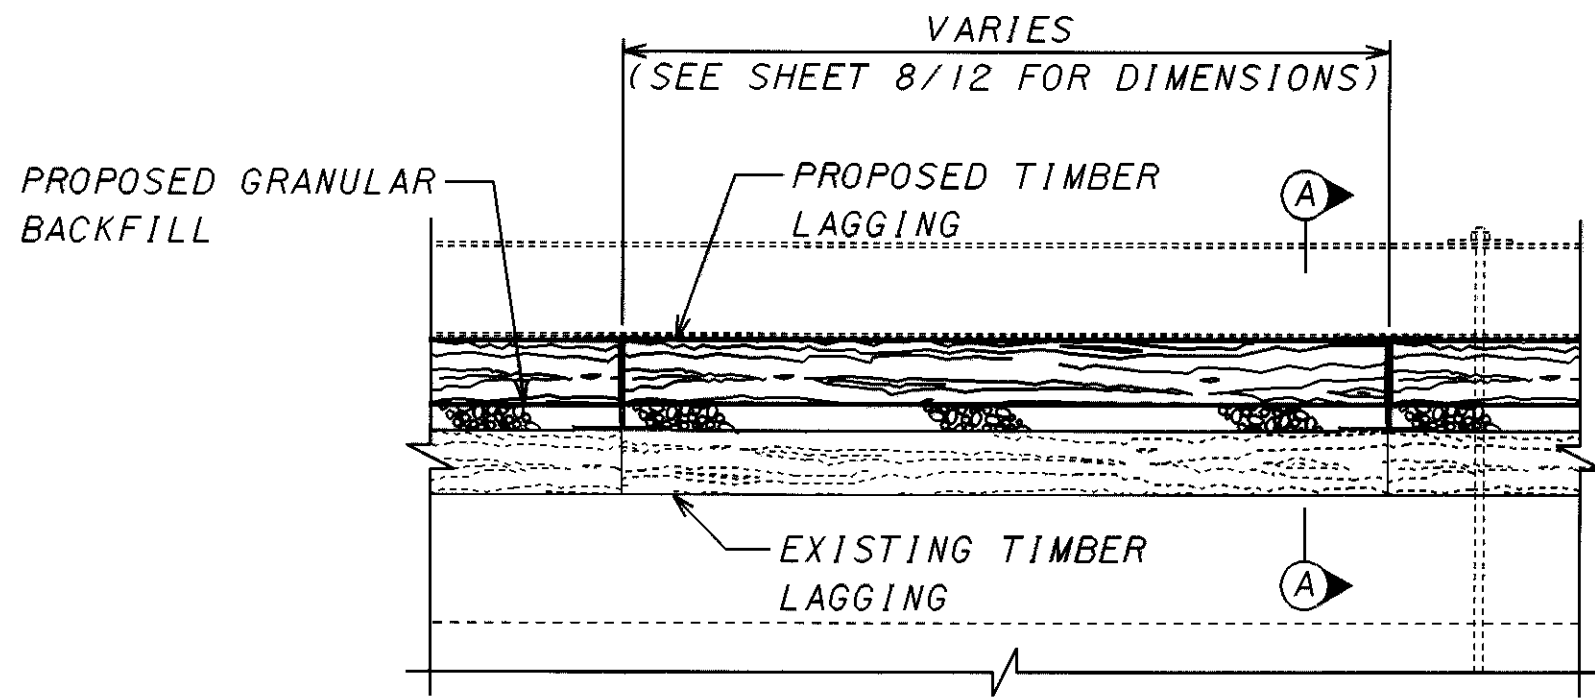
REPAIR DETAIL 1
TYPICAL OF SECTIONS 3 THRU 22

LOCATION OF TIE BARS SHALL BE DETERMINED IN
THE FIELD BY THE CONTRACTOR

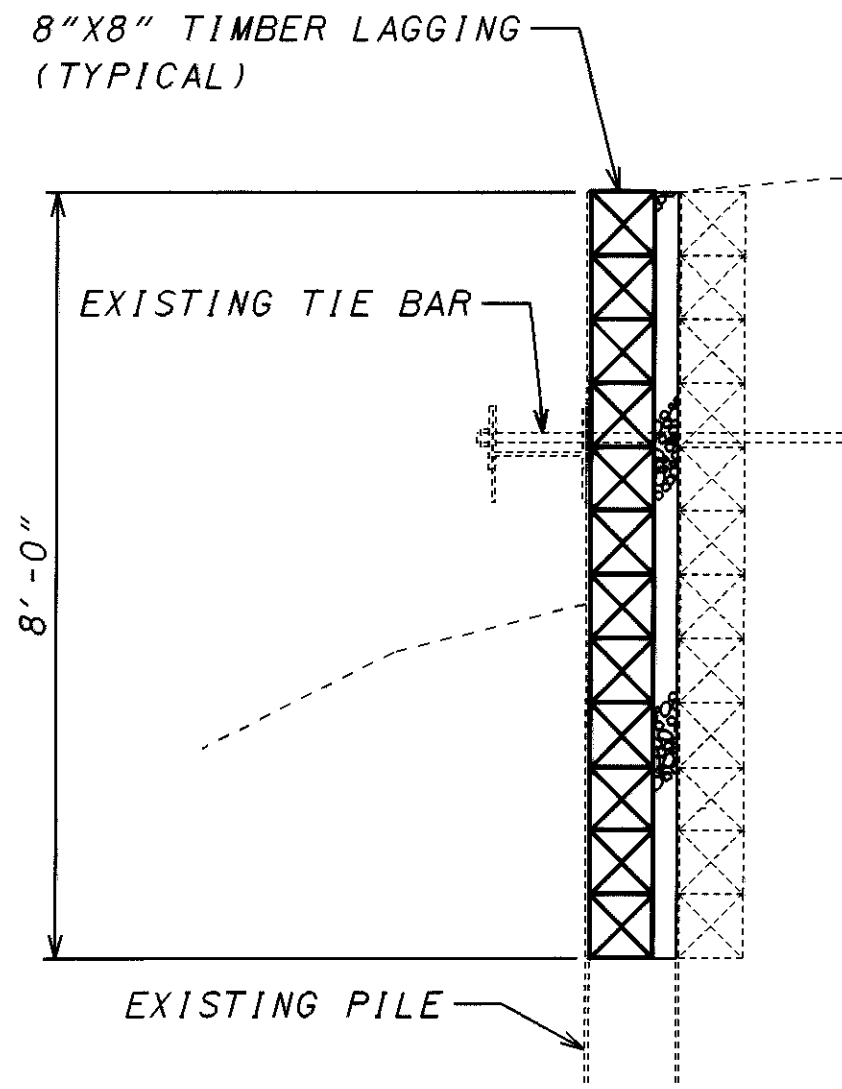
SECTION A-A

NOTE:
PROPOSED TIMBER LAGGING ADJACENT TO TIE BARS
MAY REQUIRE NOTCHING FOR PROPER PLACEMENT
