SITE PLAN
S.H.(I.C.H.) NO. 153 SEC. "H"
BATES CREEK
LAKE COUNTY
STATE OF OHIO

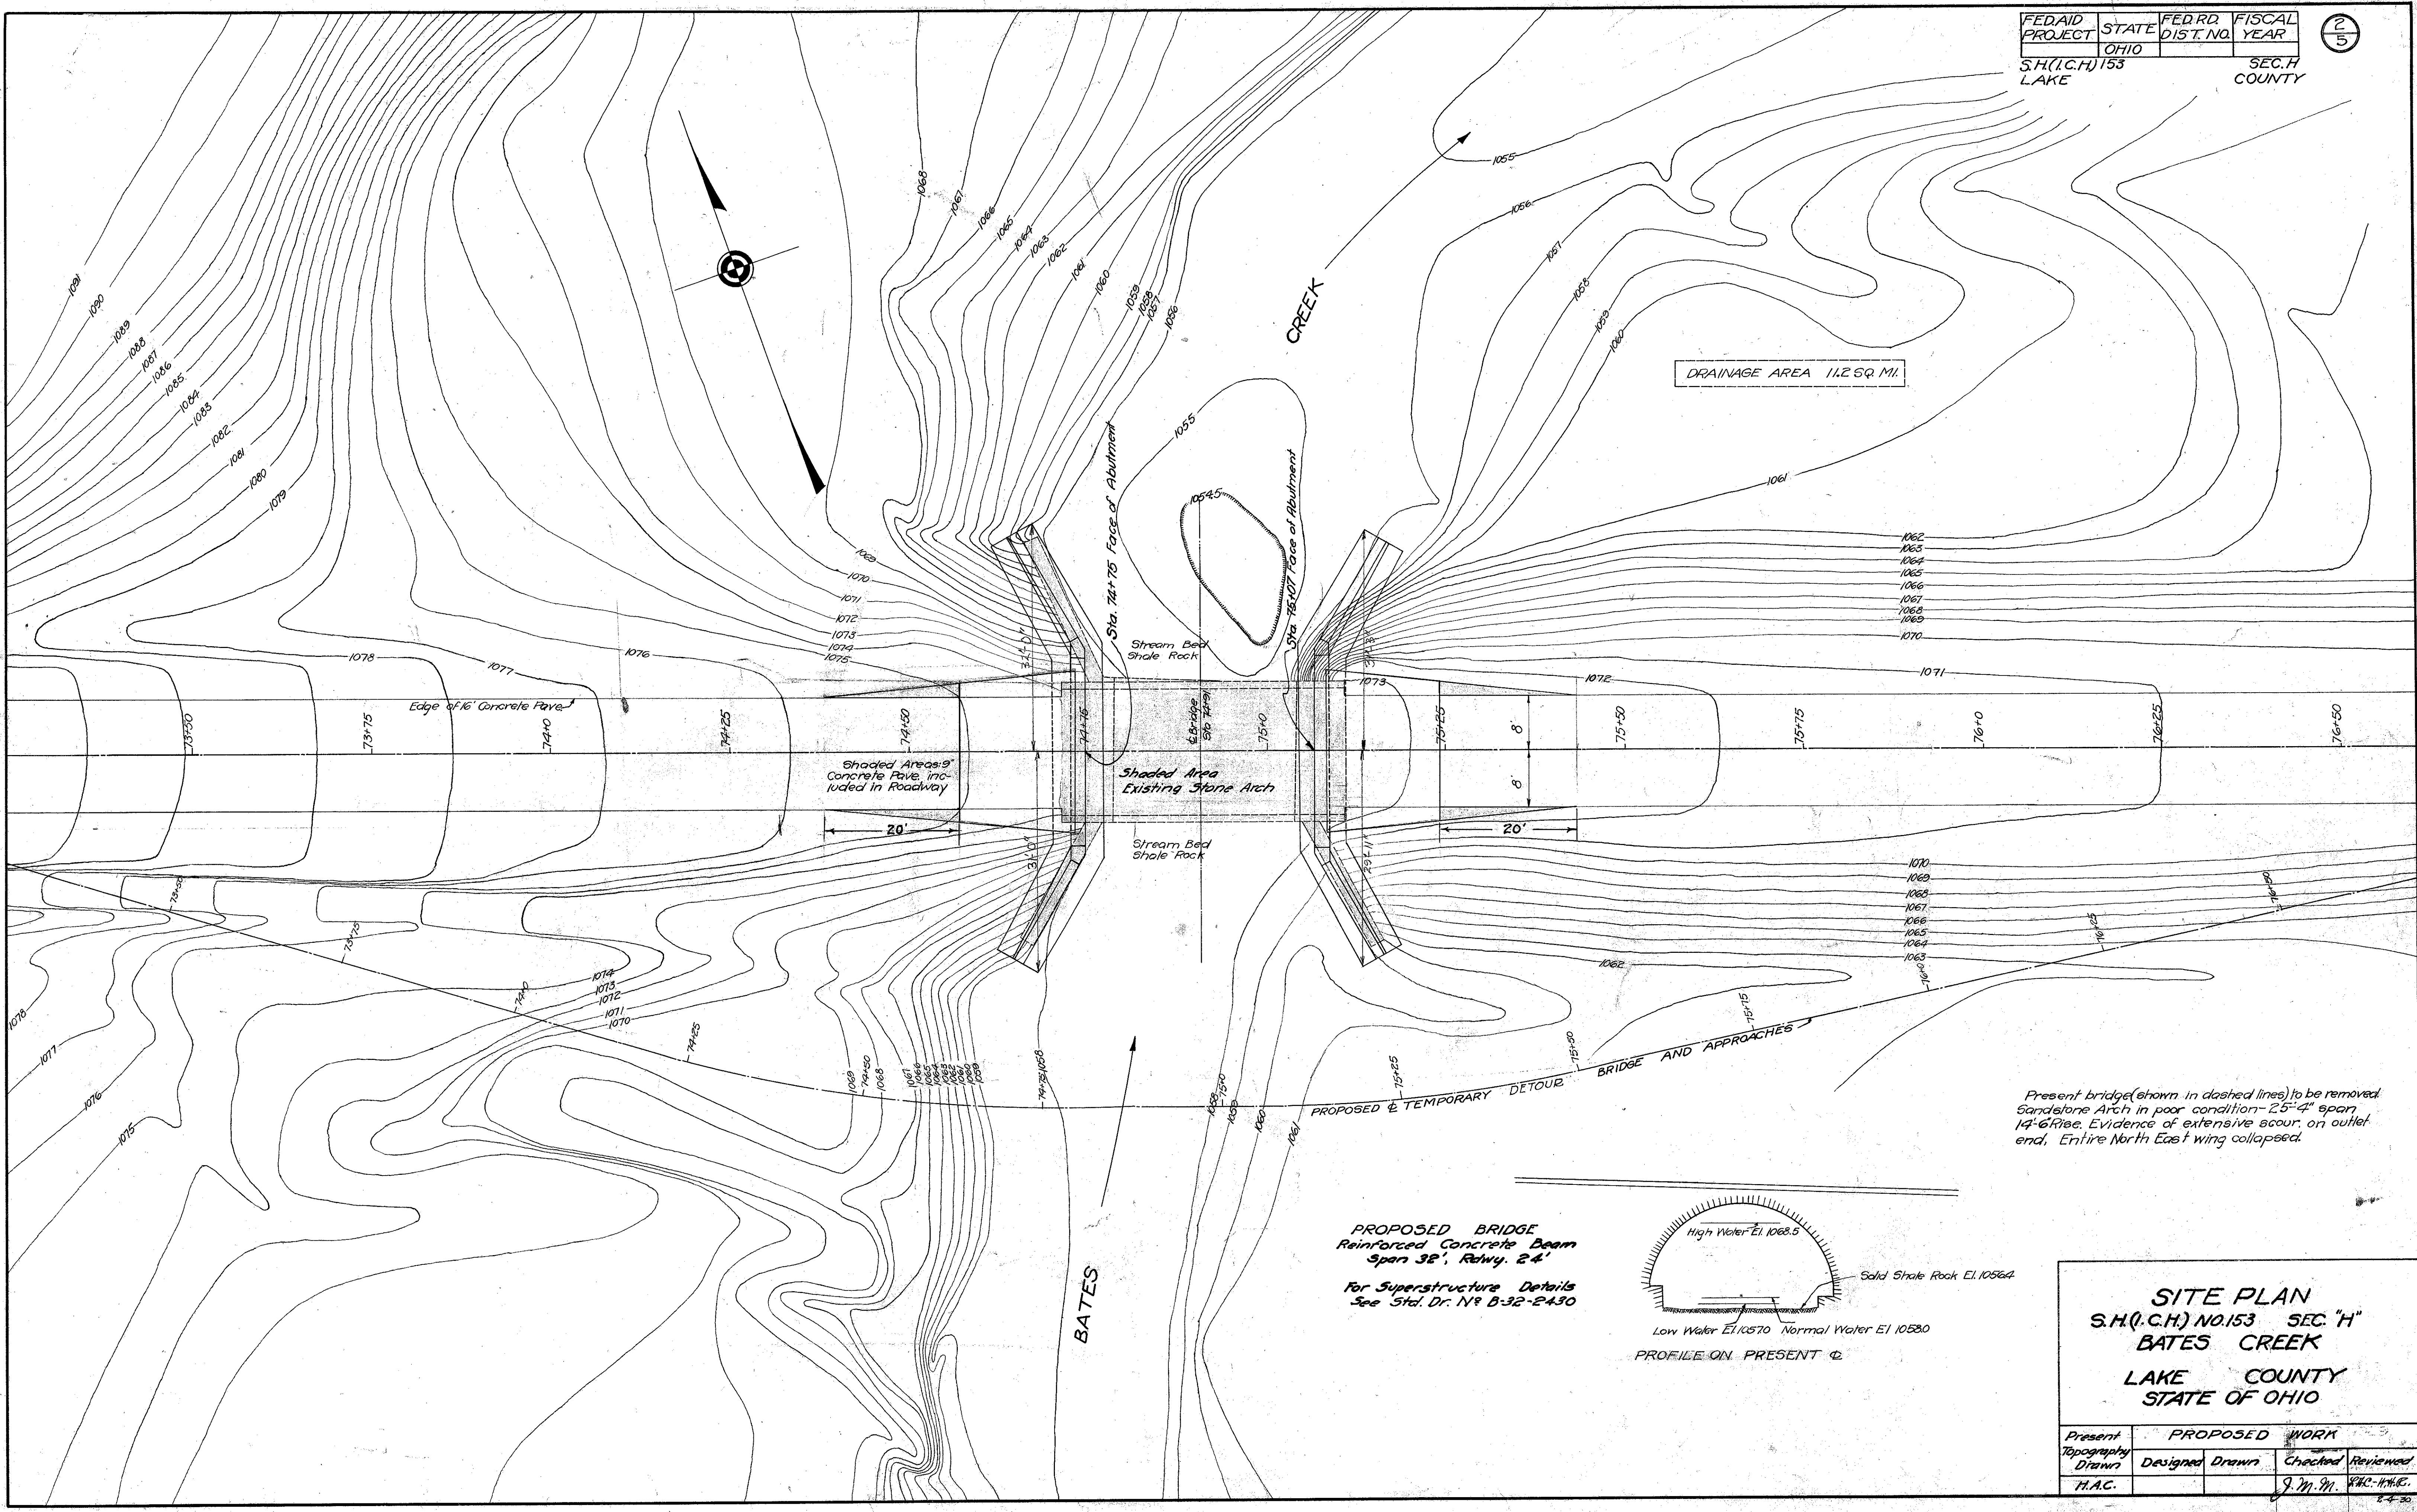
Present bridge (shown in dashed lines) to be removed. Sandstone Arch in poor condition - 25'-4" span 14'-6" rise. Evidence of extensive scour on outlet end. Entire North East wing collapsed.

PROPOSED BRIDGE
Reinforced Concrete Beam
Span 38', Rdwy. 24'
For Superstructure Details
See Std. Dr. N.B. 32-2430
