MISCELLANEOUS DETAILS

LAK-90-4.10

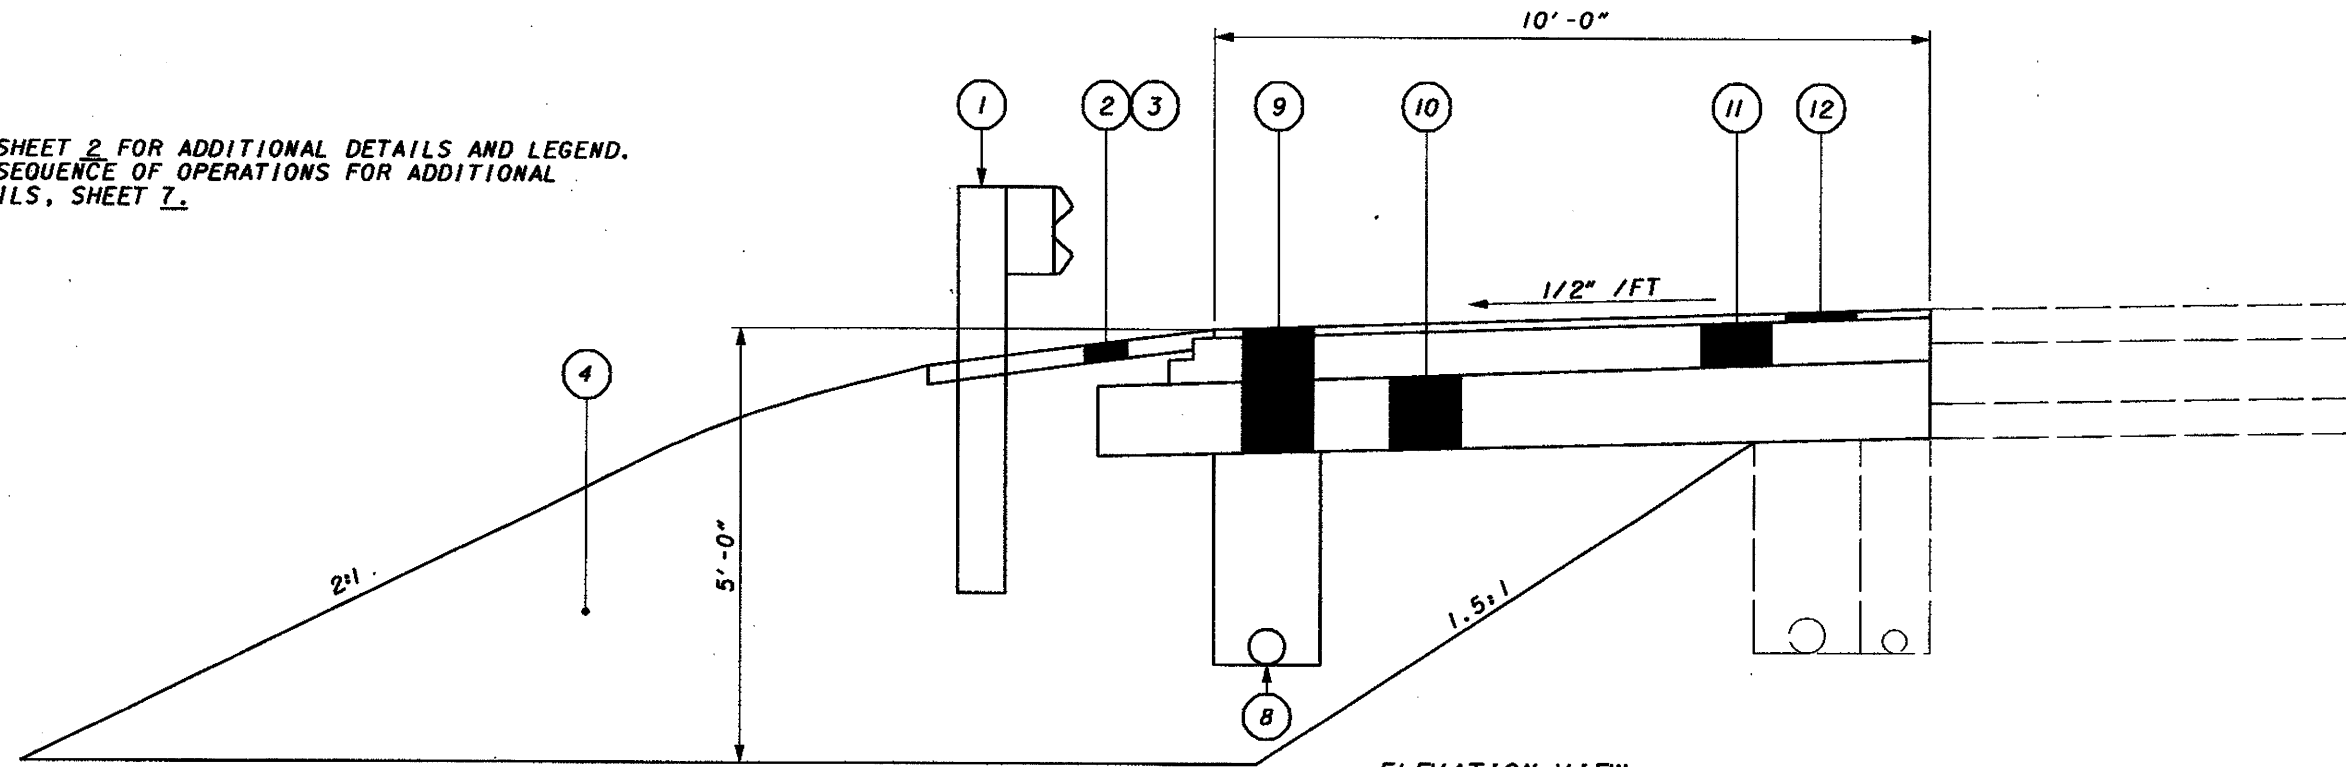
ELEVATION VIEW
SHOULDER REPAIR W.B. 1R-90
STA. 174+30 TO STA. 177+00

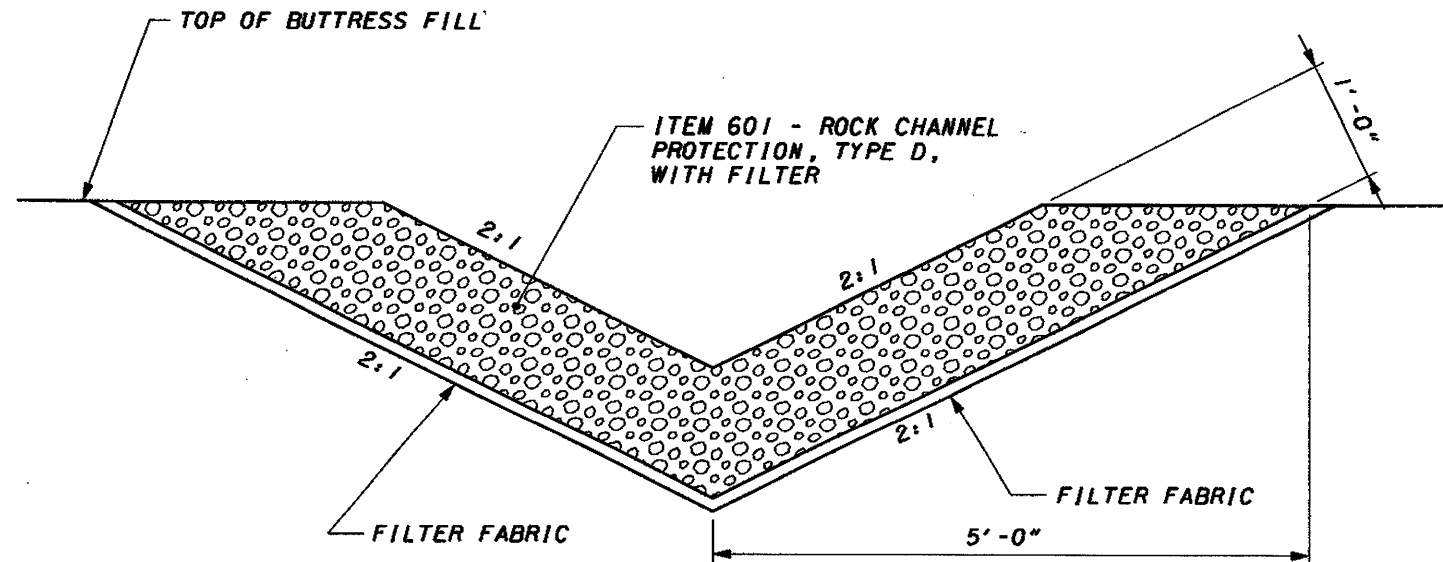
ELEVATION VIEW
ROCK CHANNEL PROTECTION ON BUTTRESS FILL
STA. 175+46 TO STA. 175+58
