Lake County  
LAK-2-5.96

OHIO  
FHWA  
REGION 5

17  
31

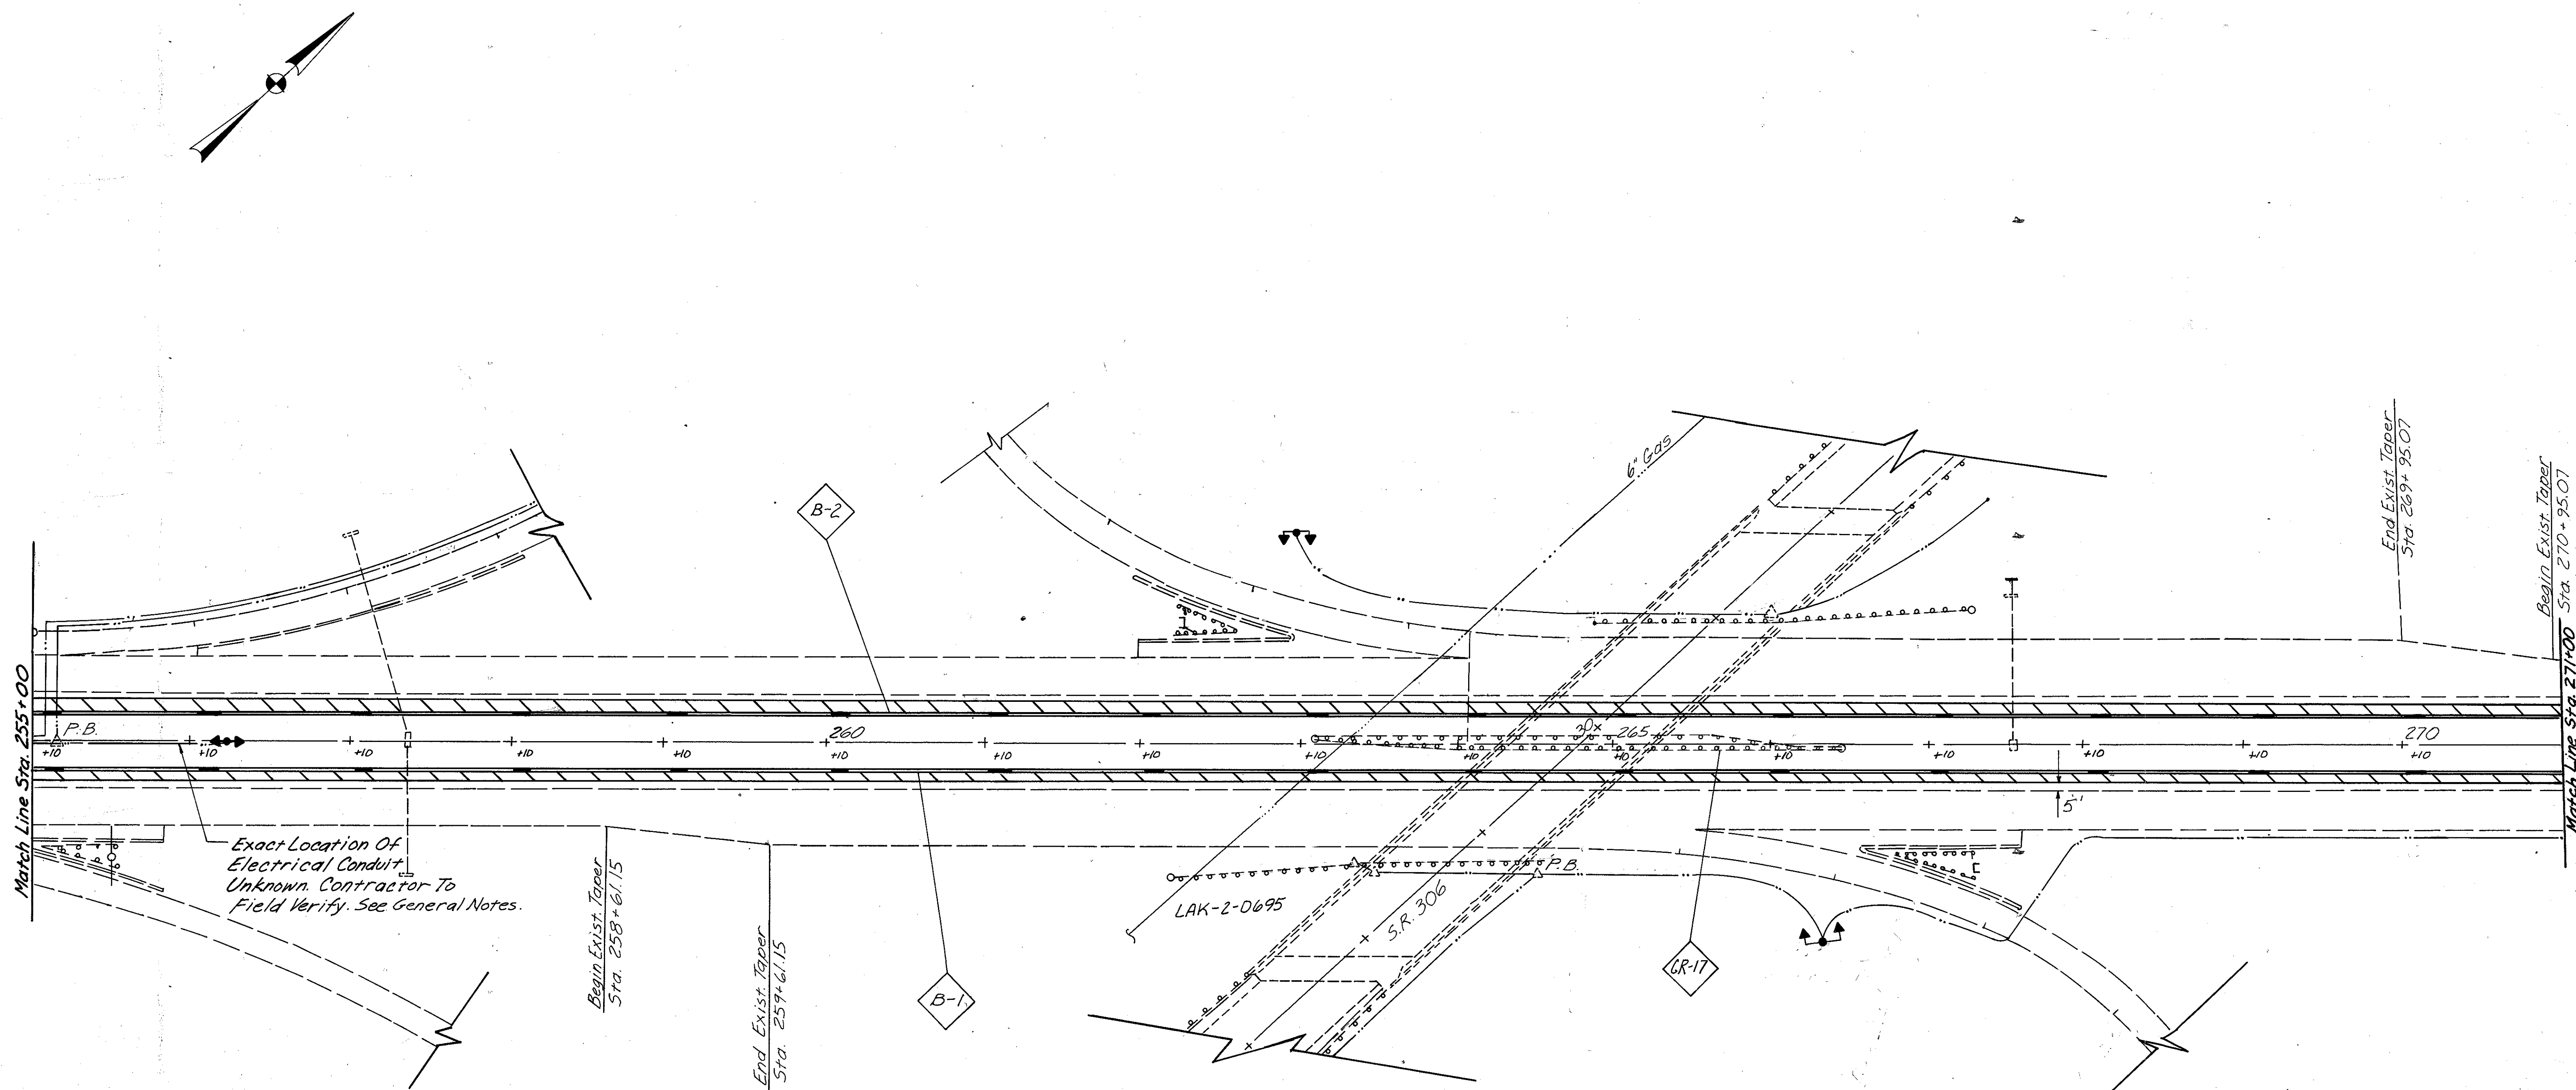
Exact Location Of  
Electrical Conduit  
Unknown. Contractor To  
Field Verify. See General Notes.

Begin Exist. Taper  
Sta. 258+61.15

End Exist. Taper  
Sta. 259+61.15

End Exist. Taper  
Sta. 269+95.07

Begin Exist. Taper  
Sta. 270+95.07

Shoulder Widening  
See Quantities Sht. 10 &  
Typical Section Sht. 5
-

Concrete Median Barrier  
See Quantities Sht. 10 &  
Details Sht. 14
-

Guardrail Removed For Storage  
See Quantities Sht. 10 &  
General Notes Sht. 8
